# An IPS e.max CAD single crown - Second upper premolar in 60 minutes

## Case Description

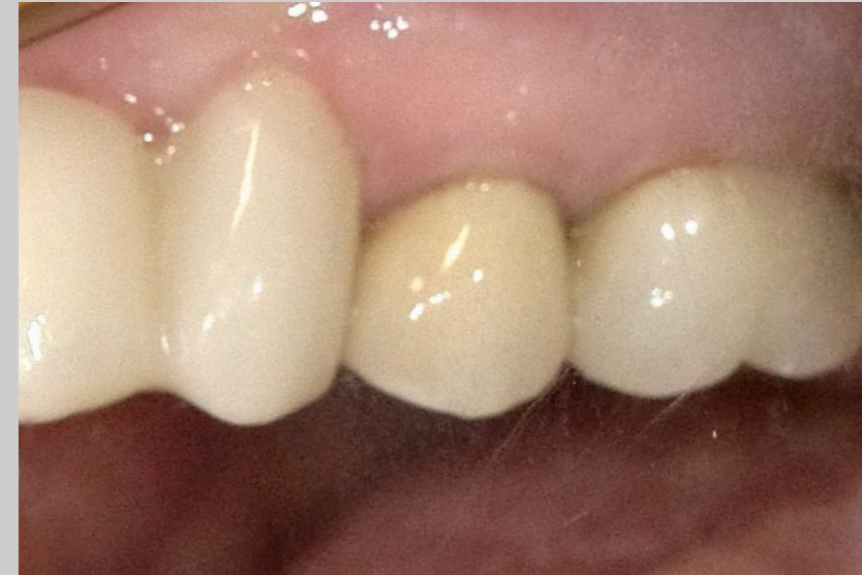
### Before:

Tooth 25 had mesial and distal marginal decay and broken porcelain on the existing PFM.

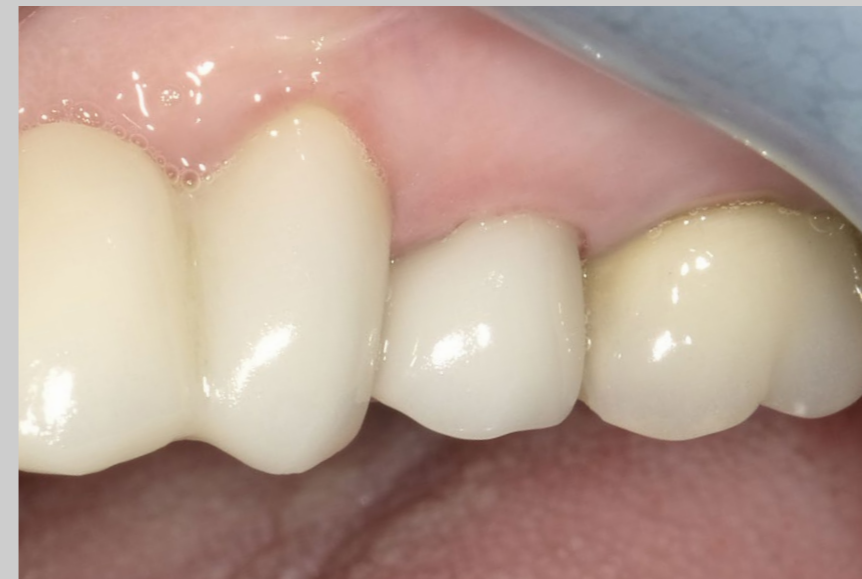
### After:

The crown on tooth 25 was remade to be brought more in line facially and incisally with the arch.

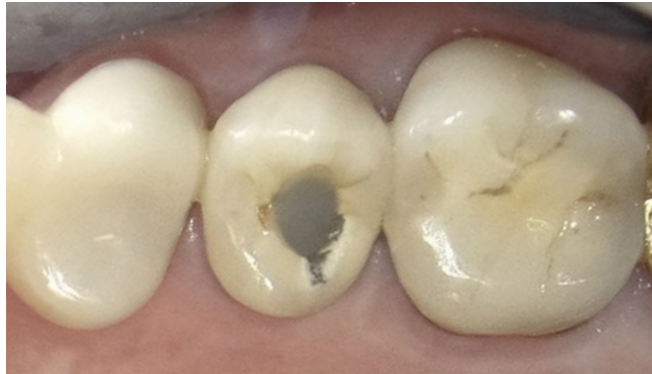
Preoperative occlusal view.

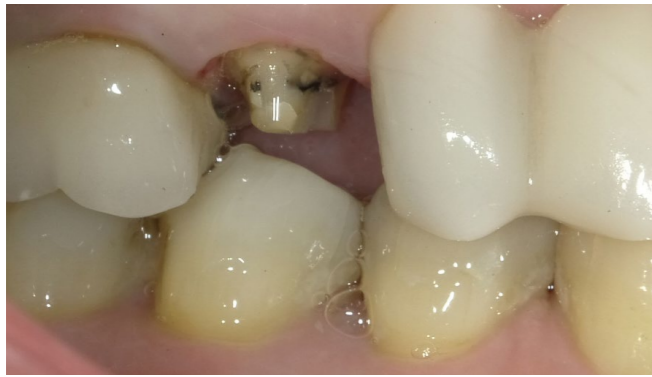
Lateral view of the preparation.

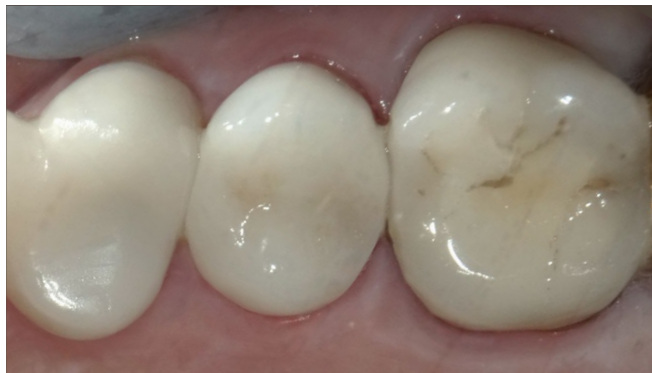
Postoperative occlusal view of finished crown.

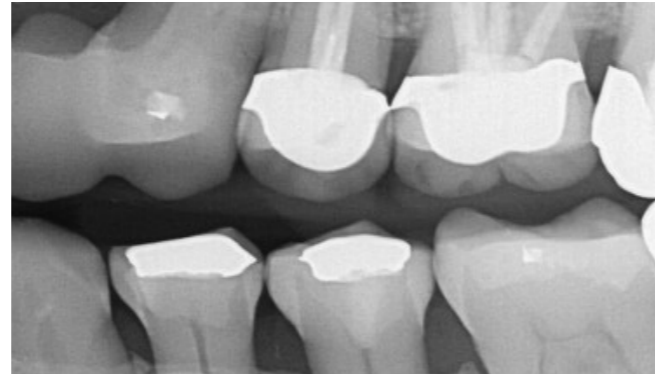
Preoperative X-ray.

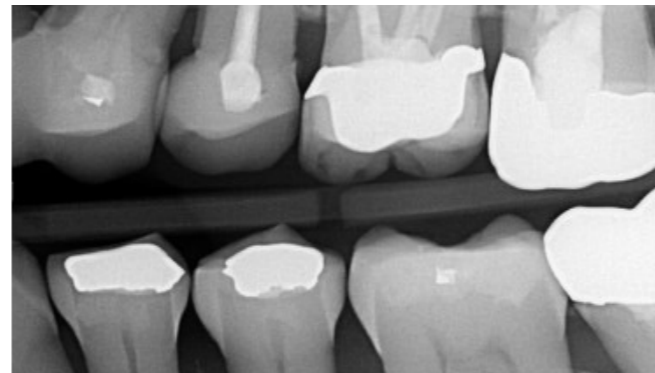
Postoperative X-ray.

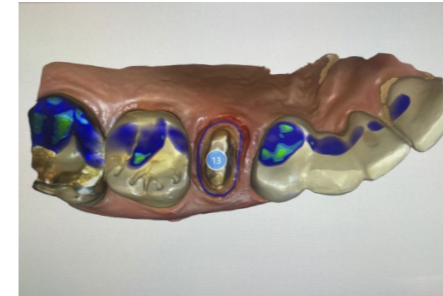
First proposal of the prep margin shows high level of accuracy.

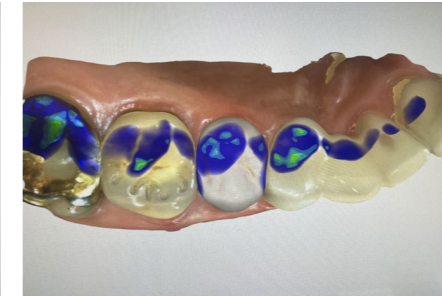
Design proposal in the CEREC SW. Minor modifications were made, which involved making a broader contact both mesially and distally.

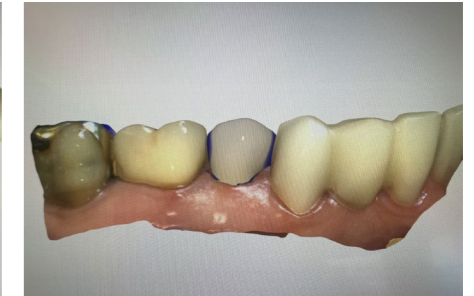
Examination of the design from different angles ensures that there is proper facial alignment.

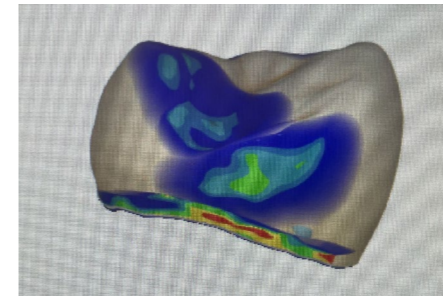
Checking contacts to ensure that they meet my desired configuration.

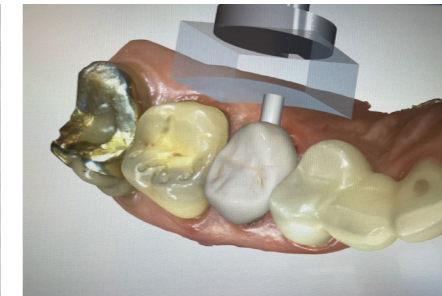
Demonstration of the crown and sprue position in the block (Manufacture phase).
