Global Clinical Case Contest 2020-2021

Student:
Rosalba Diana
Tutor:
Francesco Motta
University:
Cattolica del Sacro Cuore
Country:
Italy

Introduction to the case

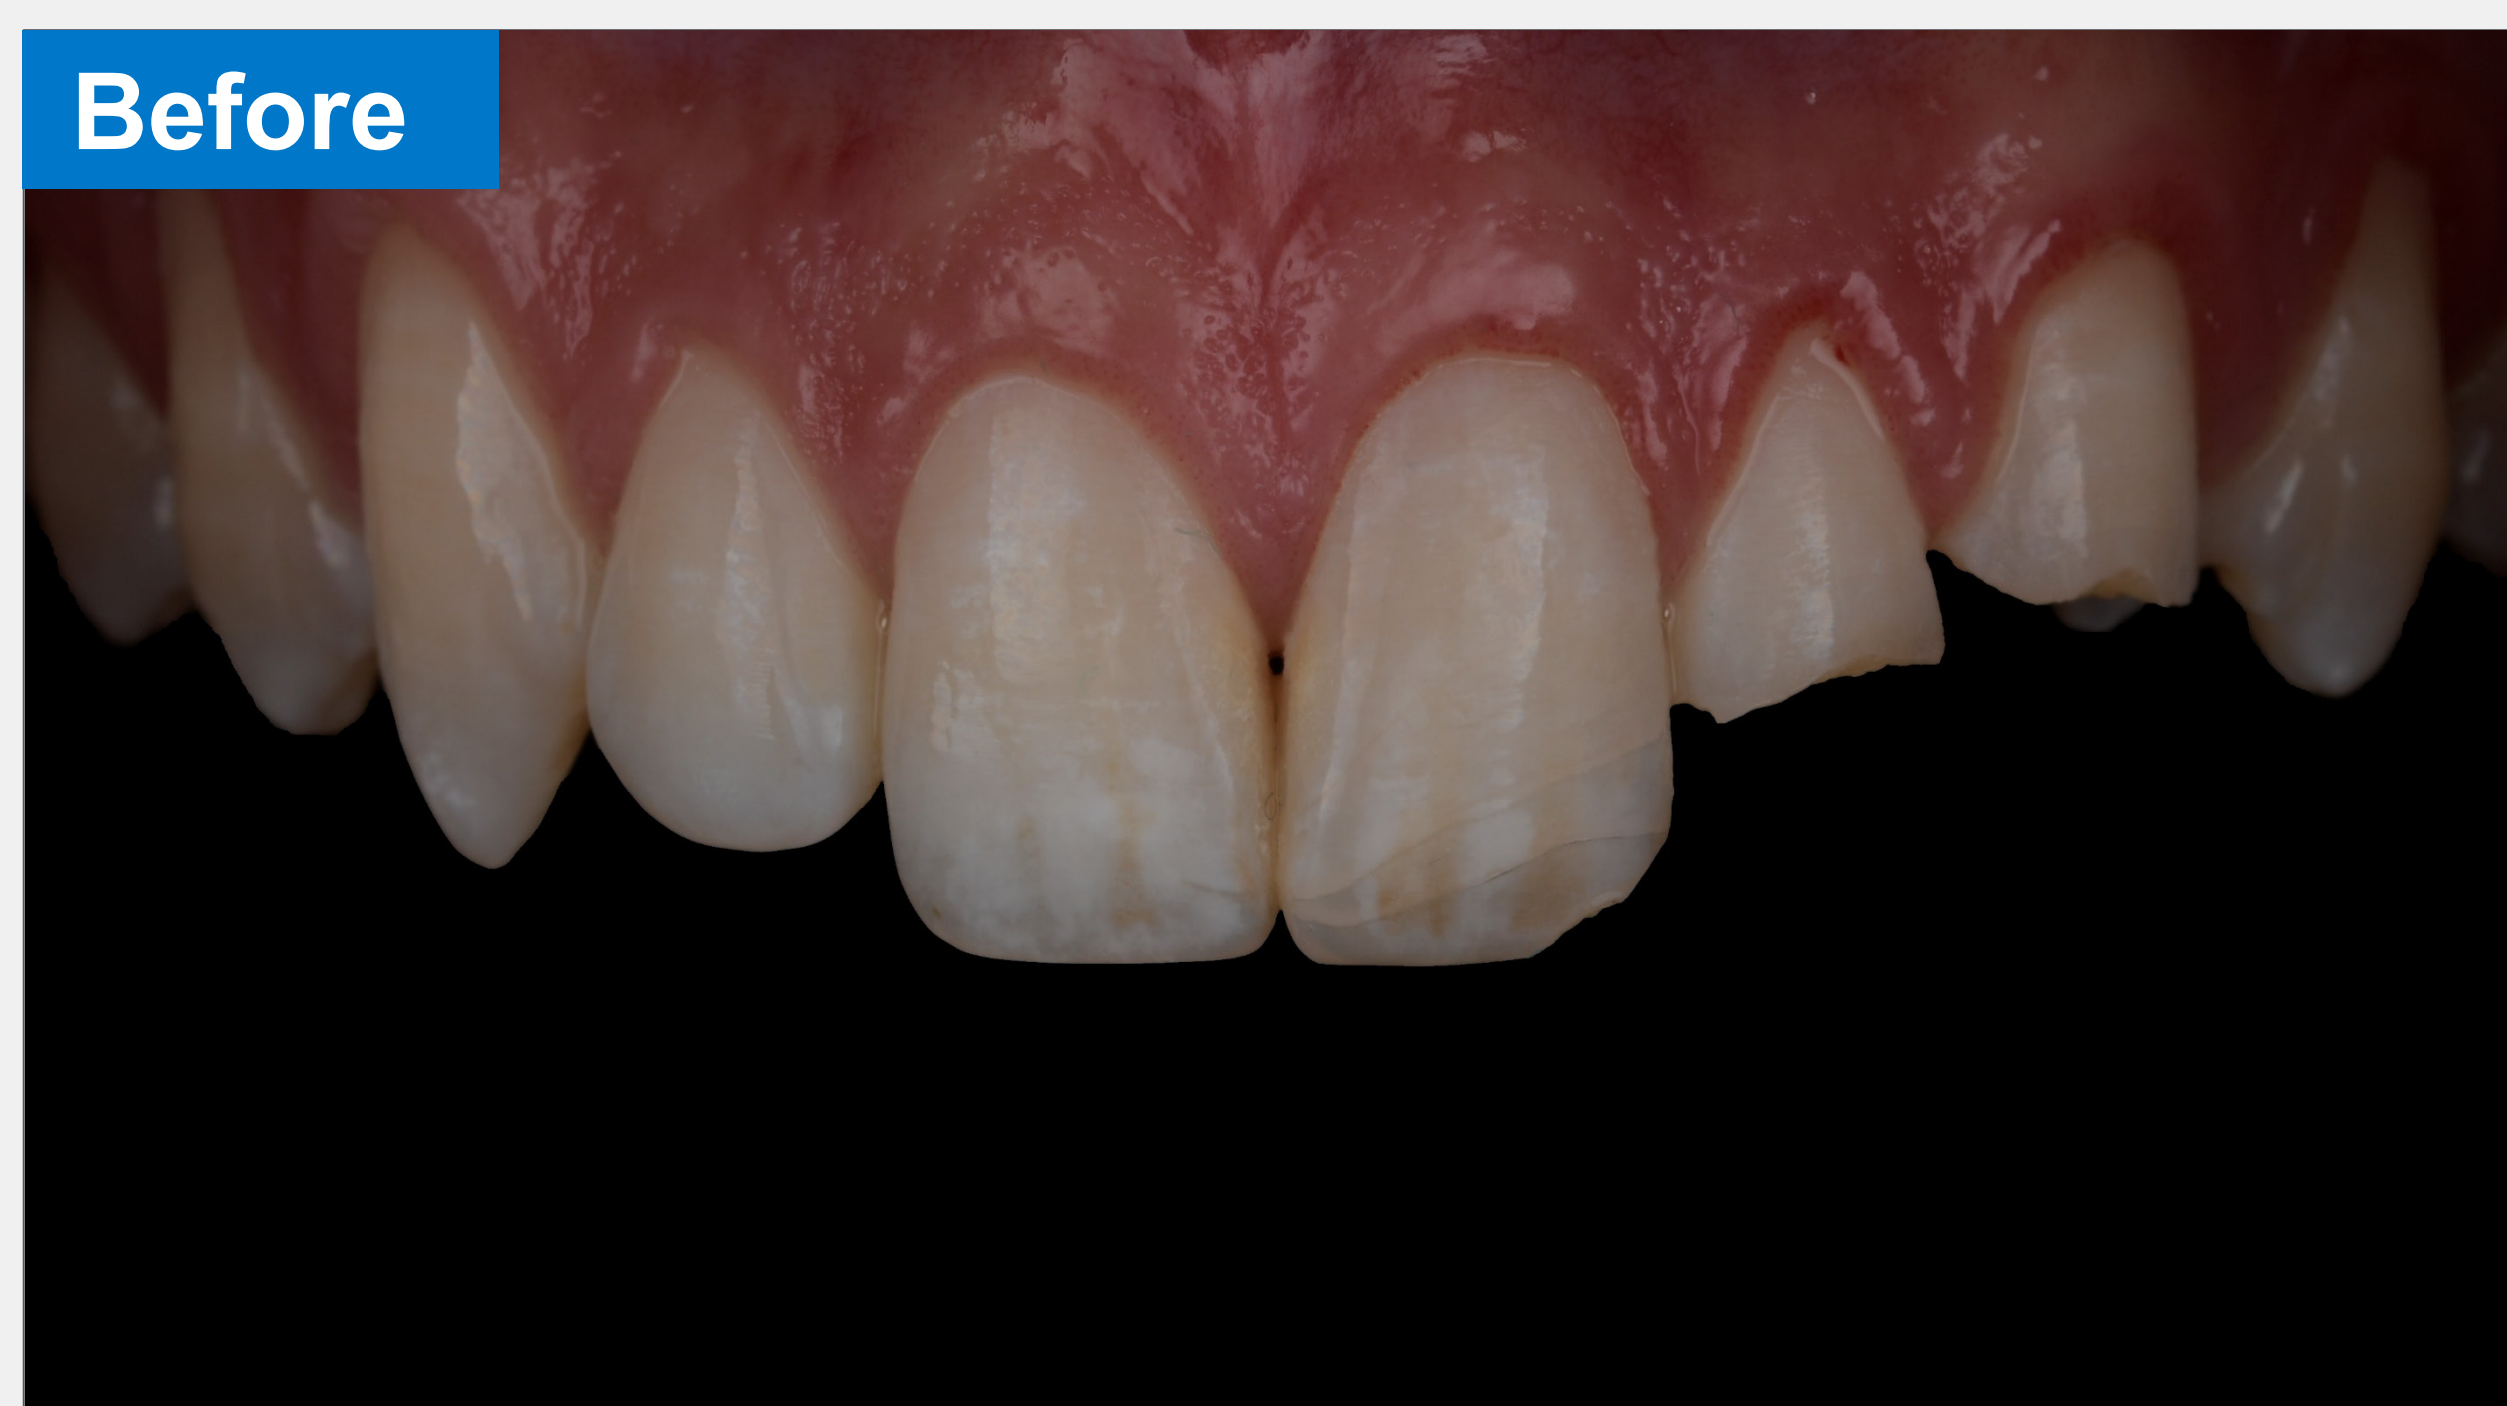
Pre-operative: frontal intraoral view, showing the fractured elements 2.1,2.2,2.3.

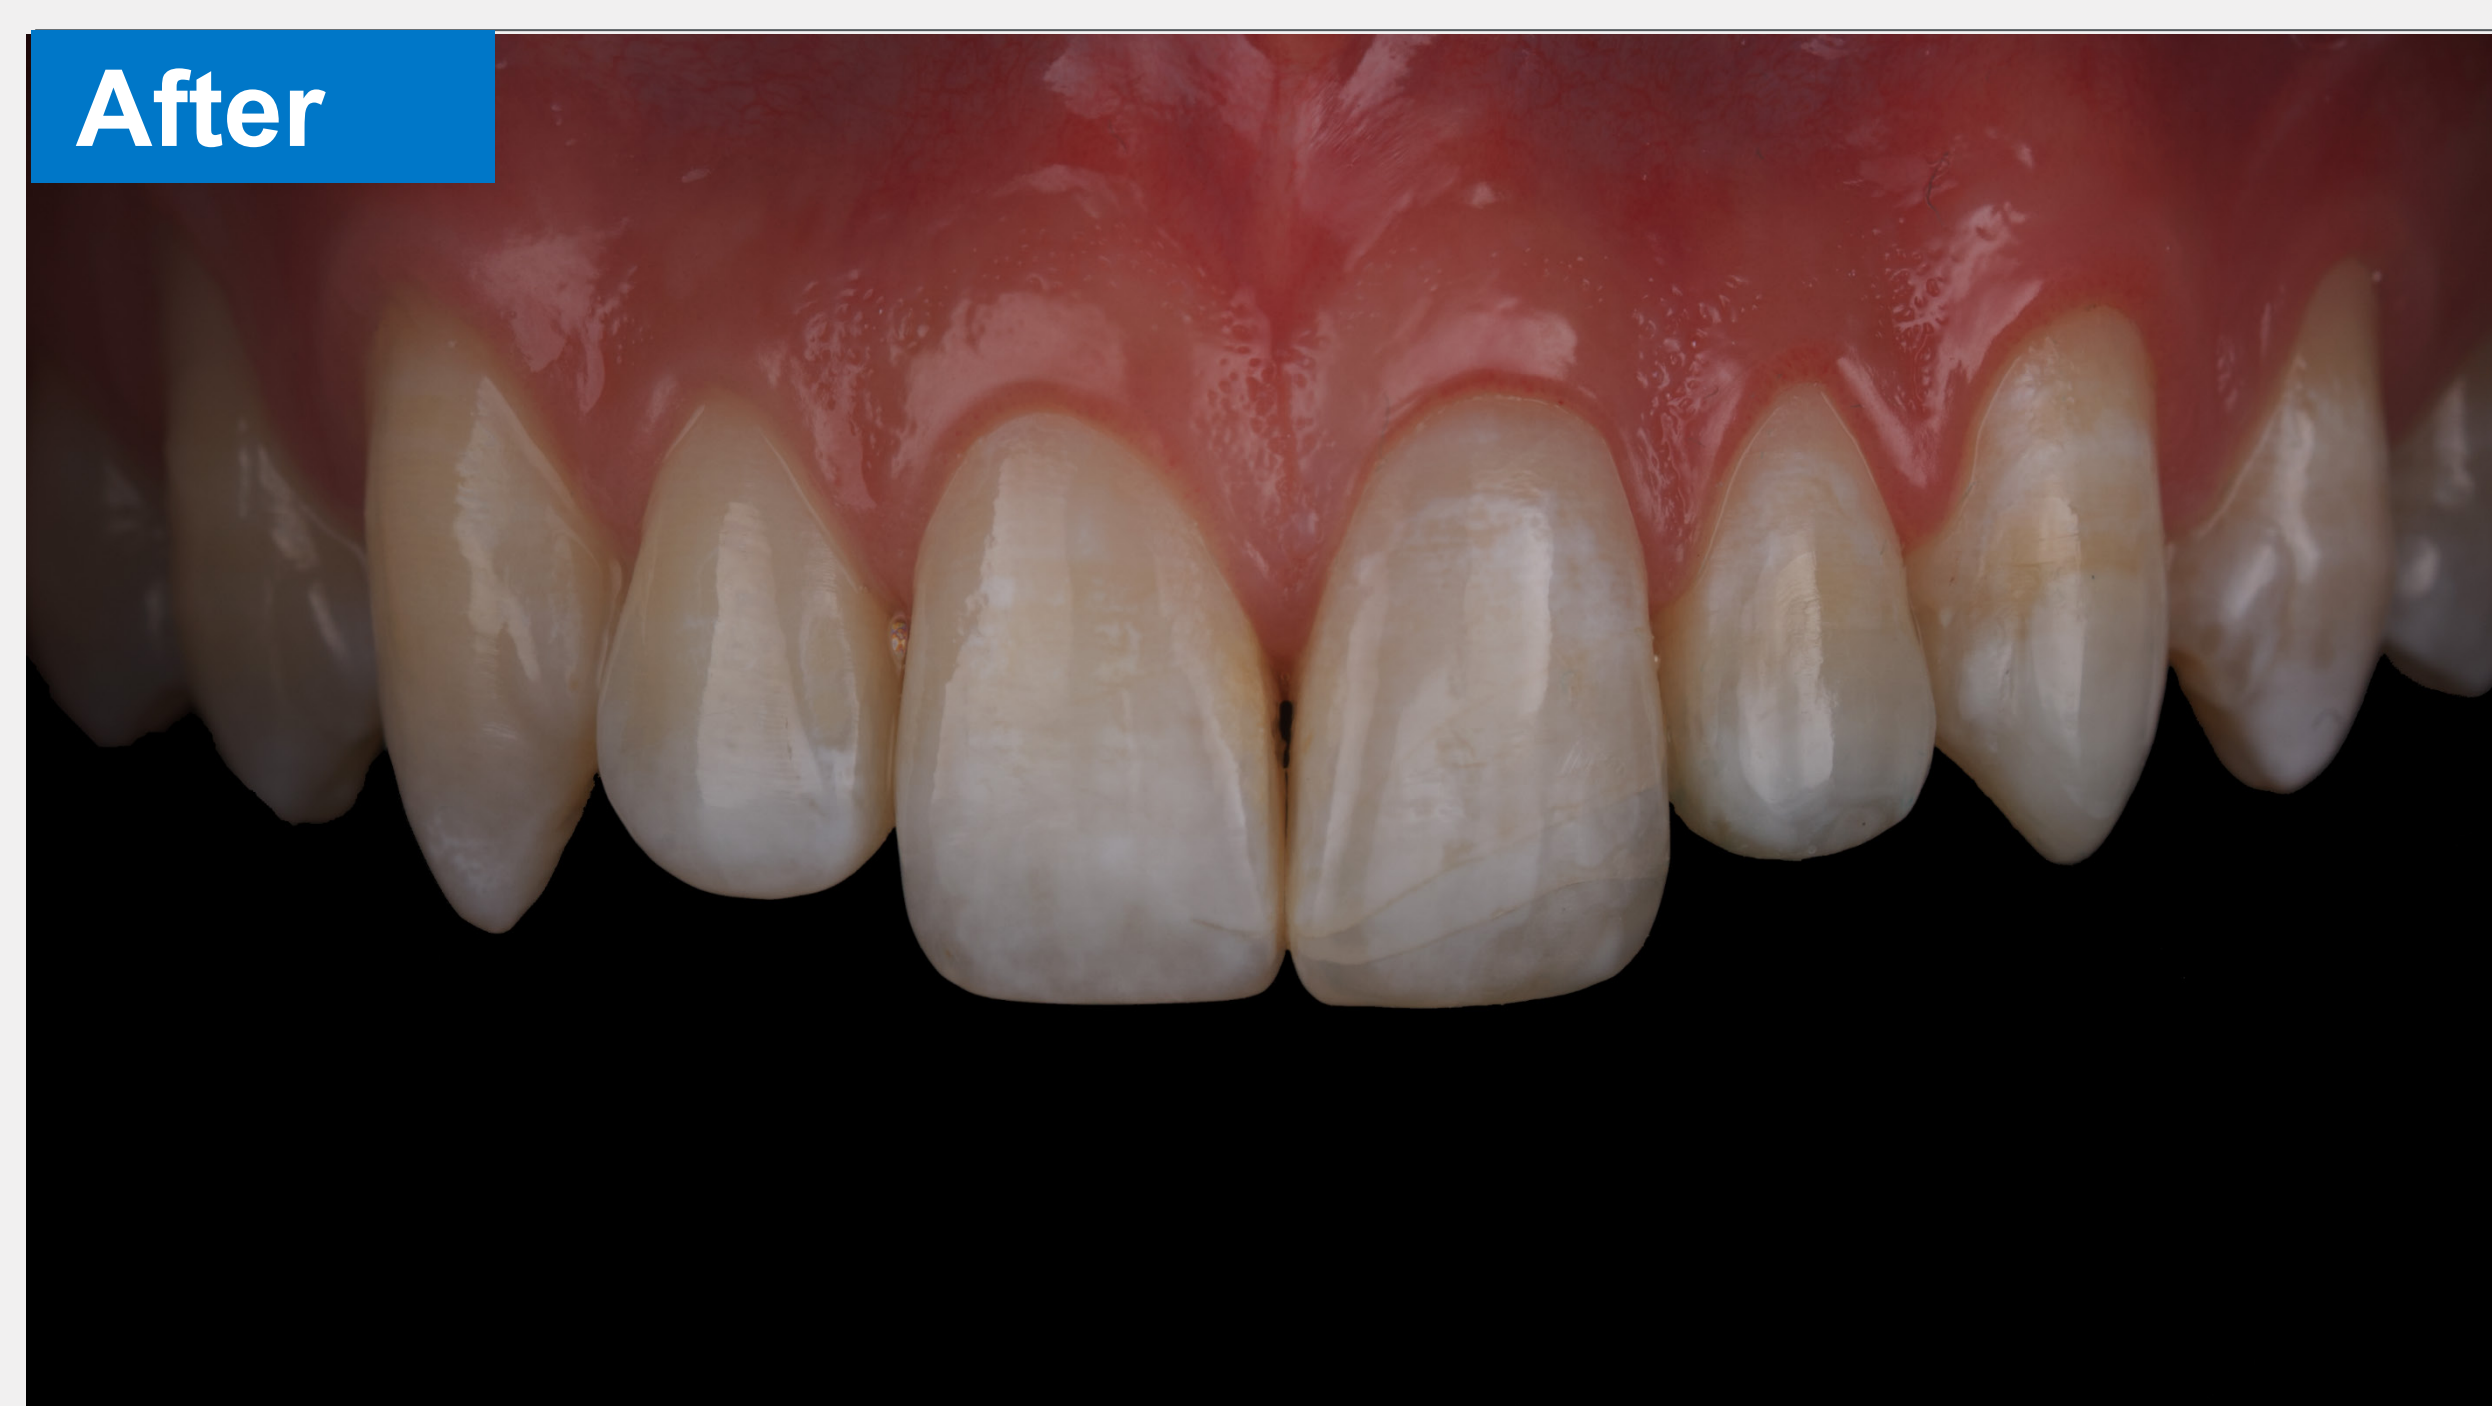
Post-operative : frontal intraoral view, showing composite restorations one week after the treatment. The smile appears natural and harmonious.

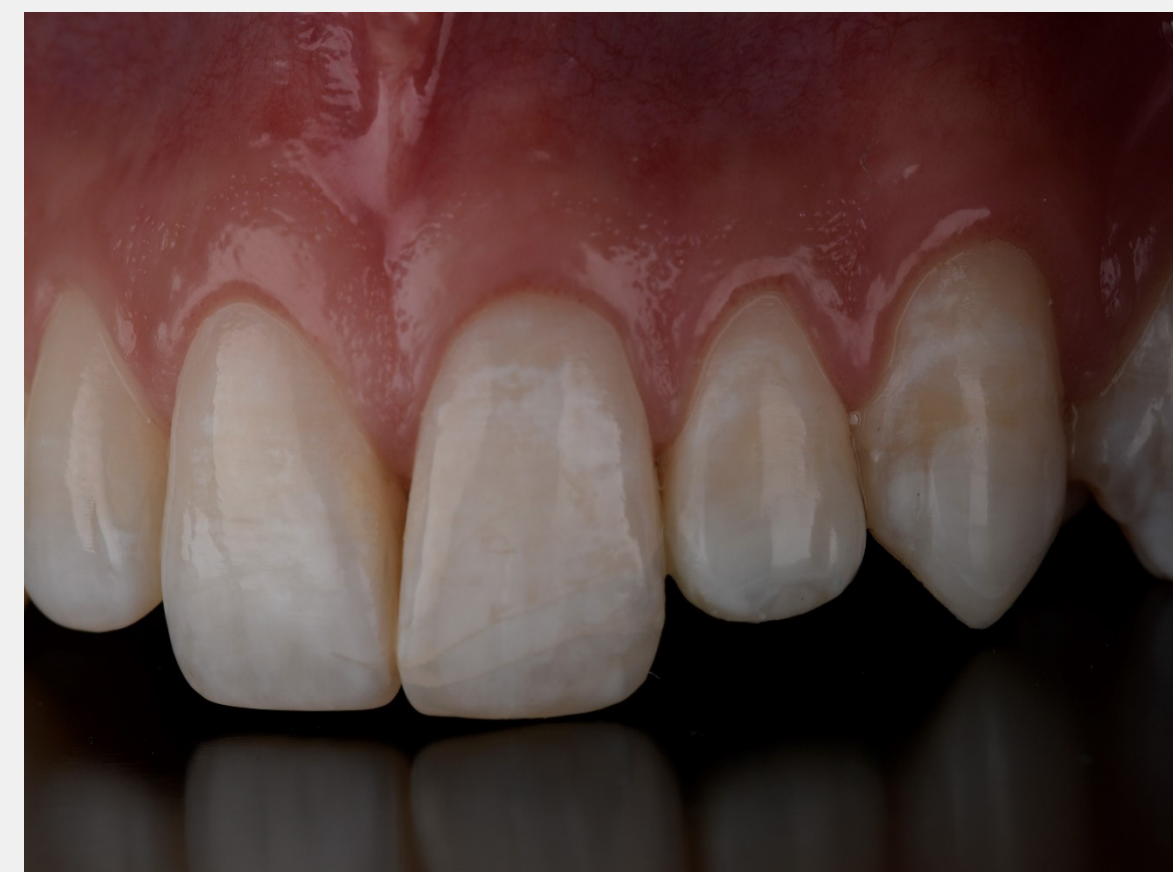
Final result

Intraoral view of final aesthetic result. It is visible the natural colour and shape of the restored teeth.
