A CEREC Tessera crown – First upper molar in 90 minutes

Case Description

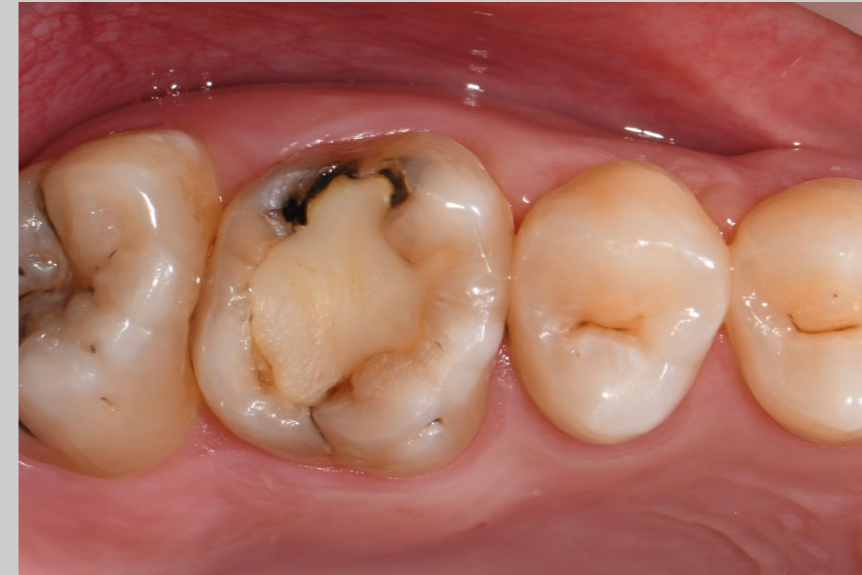
Before:

First upper molar had been restored with an extensive yet insufficient composite filling that already showed visible fractures.

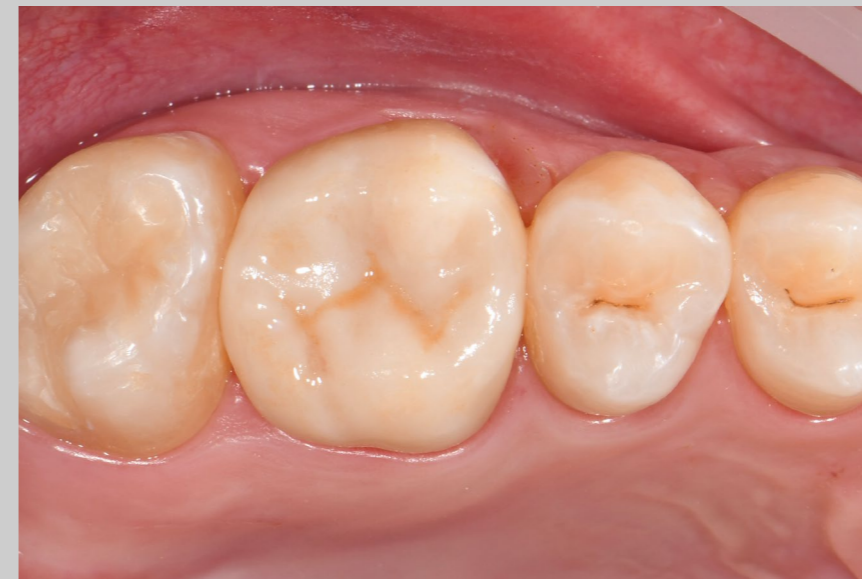
After:

Chairside-fabricated restoration made from an advanced lithium disilicate ceramic, CEREC Tessera.

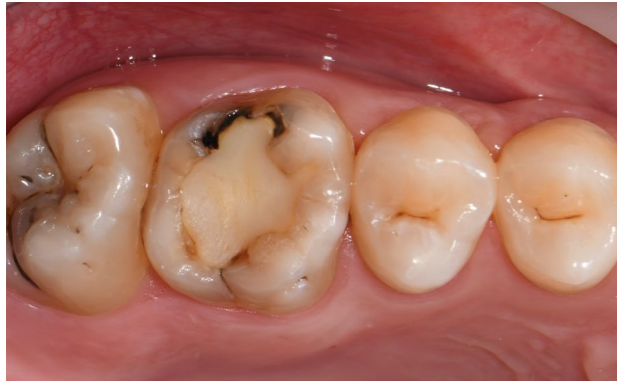
Pre-op with decay and composite filling breaking down.

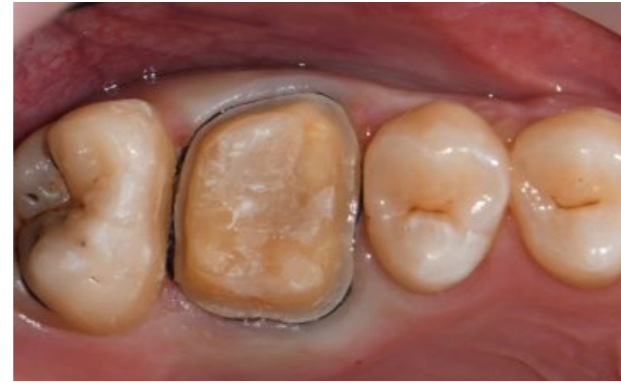
Crown preparation.

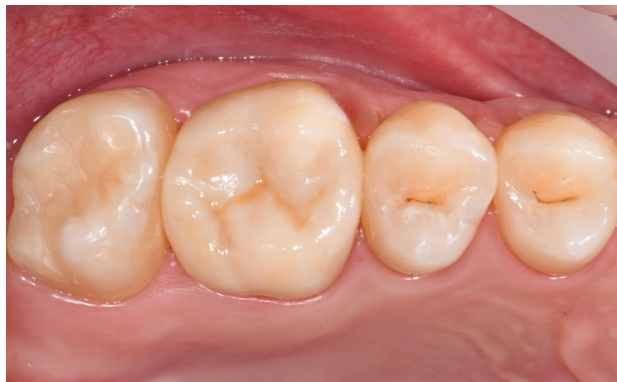
Final crown - occlusal.

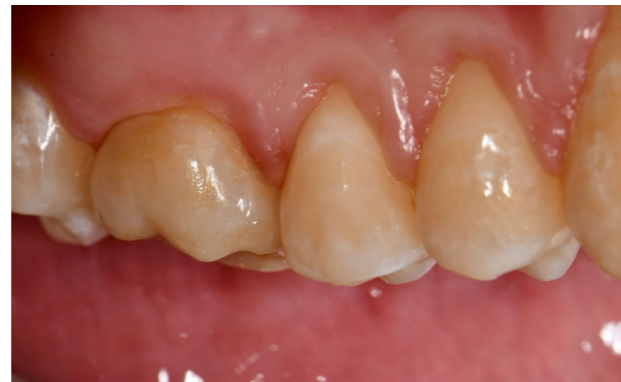
Final crown - buccal.

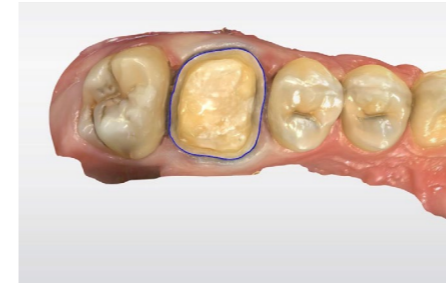
Crown margination.

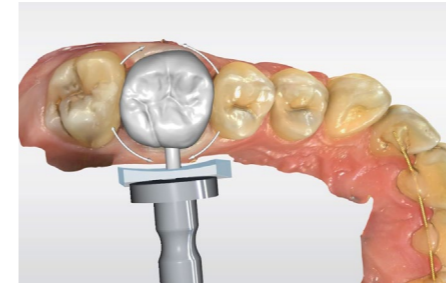
Manufacture preview of final crown.

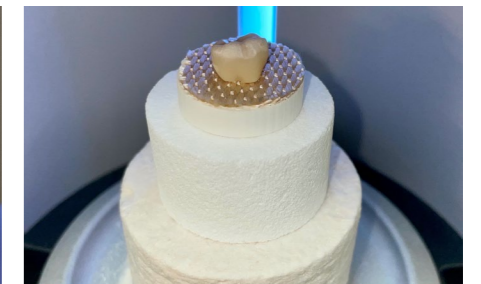
The crown is placed on top of the CEREC SpeedFire honeycomb tray with a firing pad. It must be centered on the pad. The construction is then placed in CEREC SpeedFire.
