User Case Abstract

Confident decision-making in treating dental traumas

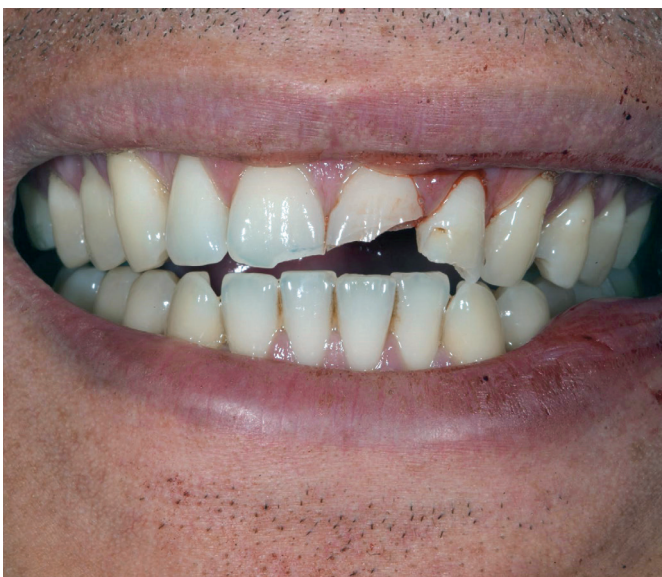
Dental trauma the patient suffered from a surfing accident.

After a surfing accident, a 31-year-old patient came to our practice for emergency treatment. He had a number of obvious visible traumas but in order to properly assess the damage we used DVT, which revealed that tooth 22 had a vertical fracture from the middle to the apical root. Tooth 23 had a lateral luxation injury and the scan also revealed a fracture of the buccal bone plate such that the top edge was no longer in contact with

the alveolar bone. Additionally, it was visually apparent that the patient had trauma in the form of lesions to the upper and lower lip mucosa, minor splintering of the incisal edge of tooth 11, and a crown fracture with exposed pulp of tooth 21.

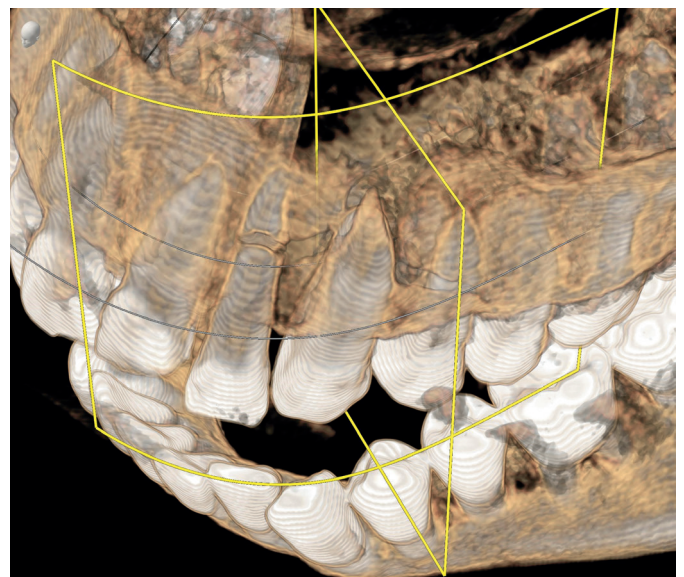
Diagnostic findings from the first DVT.

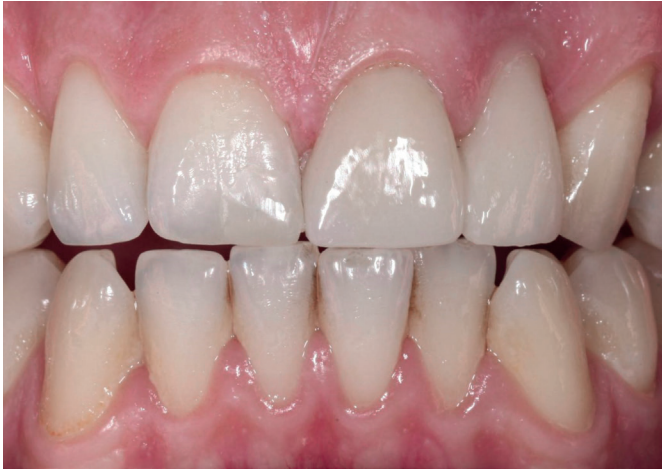
Thanks to a clear diagnosis it was possible to restore the maxilla.

The third session took place a week later where the patient received a milled and manually veneered bridge as a long-term temporary restoration while the final restoration was made with an e.max. The treatment yielded an aesthetically good result.

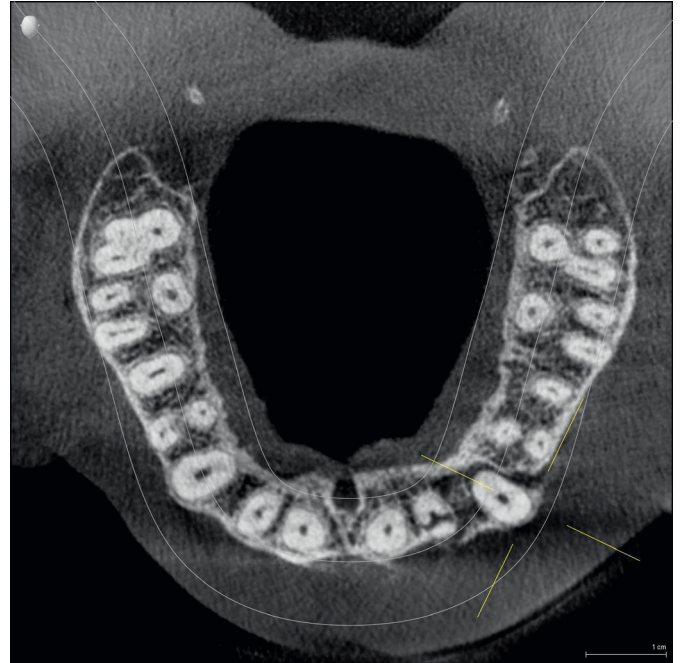
The Orthophos SL slice image very clearly shows the fracture of tooth 22 and the displacement of tooth 23.
