# An IPS e.max CAD single crown – First upper molar in 75 minutes

## Case Description

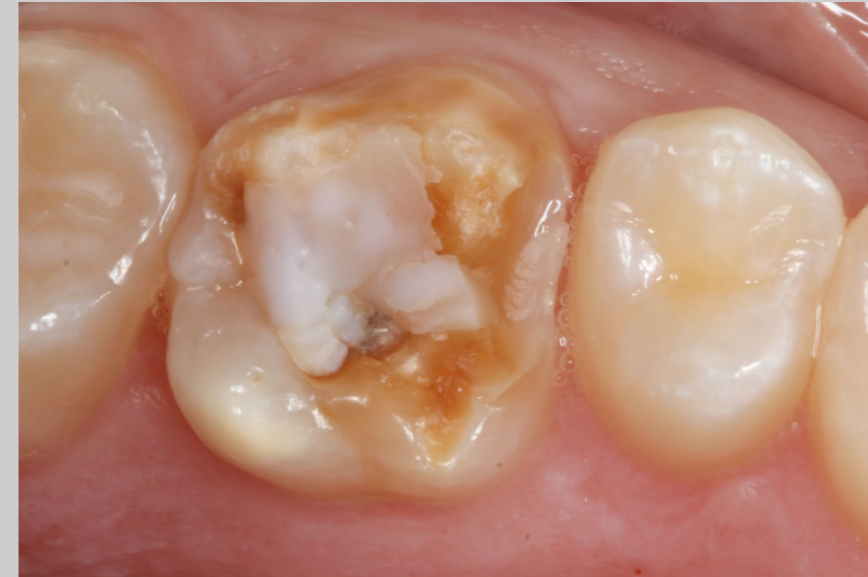
### Before:

Tooth 26 presenting decay and a failing direct composite restoration.

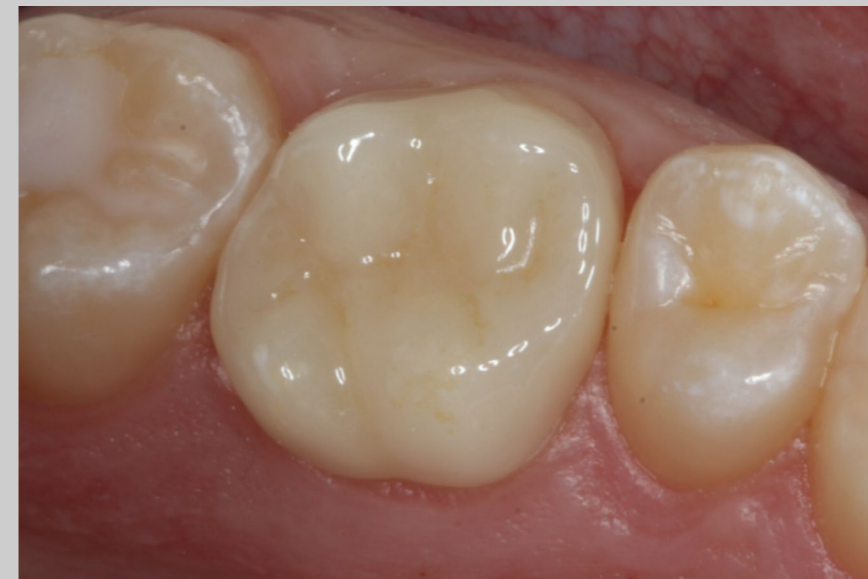
### After:

Highly esthetic and functional lithium disilicate ceramic crown.

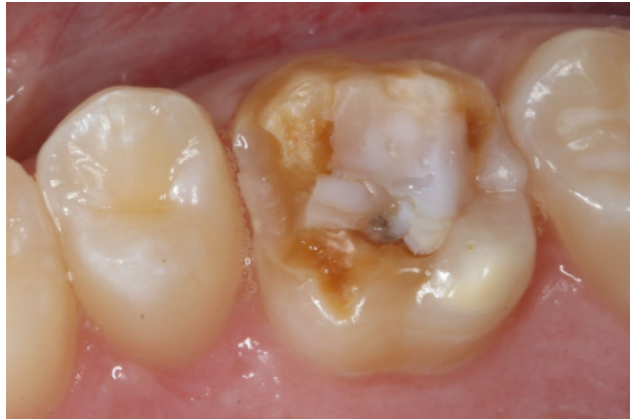
Pre-op tooth 26 with a failing composite restoration and recurrent decay.

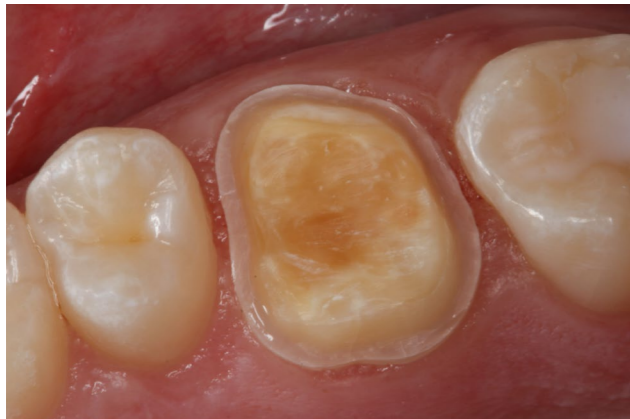
The old restorative material and the decay were removed, and the tooth has been prepared for a full-coverage crown.

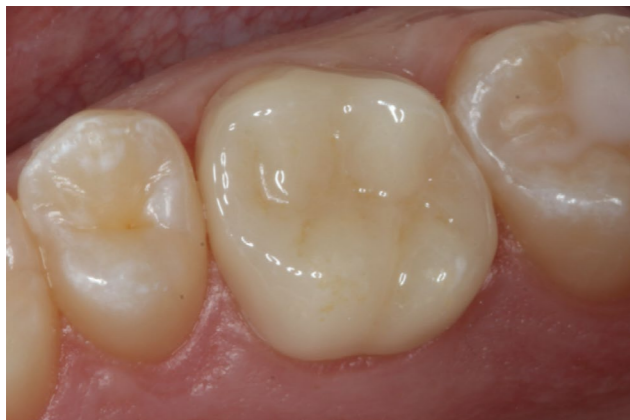
The final e.max crown bonded in place.
