An IPS e.max CAD single crown – First upper molar in 60 minutes

Case Description

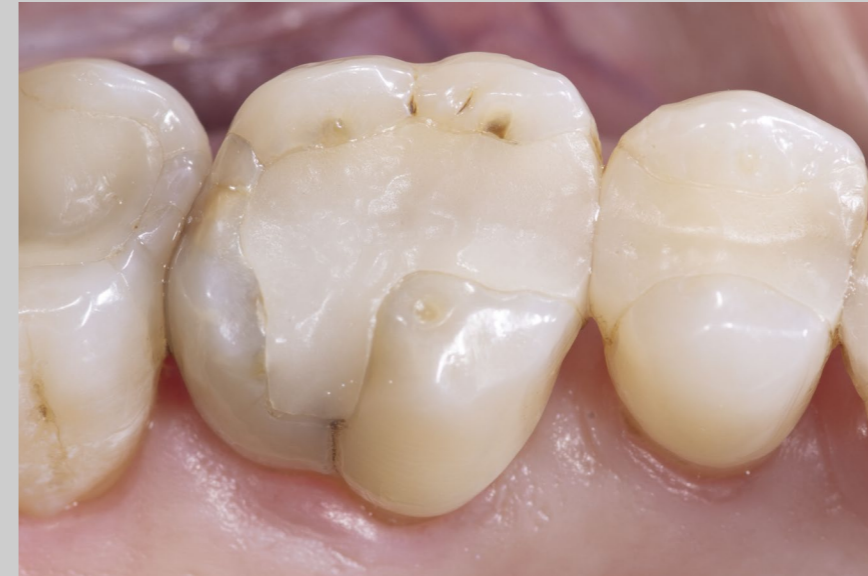
Before:

Large insufficiency of the composite filling on tooth 16 with distal marginal ridge cracks, a lingual wall crack, and distal recurrent decay.

A female patient, 47 years old, presented with a slightly intermittent sensitivity to cold at tooth 16. The clinical examination as well as the radiological findings indicated a large insufficiency of the composite filling, with distal marginal ridge cracks, a lingual wall crack, and distal recurrent decay. The tooth was not sensitive either to percussion or palpation, and showed no signs of apical inflammation. A cracked tooth syndrome was diagnosed. Due to the size of the filling and the caries to be treated, a core buildup and a full cuspal coverage ceramic crown restoration was planned. After local anesthesia with 4% Septocaine® (1:100,000 epi), we selected the material and the color for the restoration: IPS e.max CAD MT A3. Prior to the preparation and design of the new restoration, my assistant prepared the CEREC Primemill by inserting the block and starting the pre-touch process. After the initial scan of the upper and lower jaw with CEREC Primescan, I removed the filling. This confirmed the initial diagnosis of a fracture in the lingual wall. Following the excavation, I applied a composite core buildup (3M Vitrebond, Empress Opaque, Ivoclar Vivadent). In this case, I was able to complete the preparation in a way that the enamel was retained in the buccal wall. Subsequently, I took a new digital impression with the CEREC Primescan. I then defined the preparation line in the digital model. The CEREC Software provides excellent support in this respect. I was satisfied with the first restoration proposal, which I accepted without any changes. During the design phase, I paid particular attention to the fissure height and contours, the correct occlusion, and the contact points. After grinding with CEREC Primemill, I crystallized and glazed the crown. I performed a quick final check and could place the crown using adhesive. The patient was very happy with her experience and grateful for being able to have her tooth restored with a permanent, strong, and highly esthetic crown in a single visit that took just over an hour. Since then, she has been completely free of symptoms.

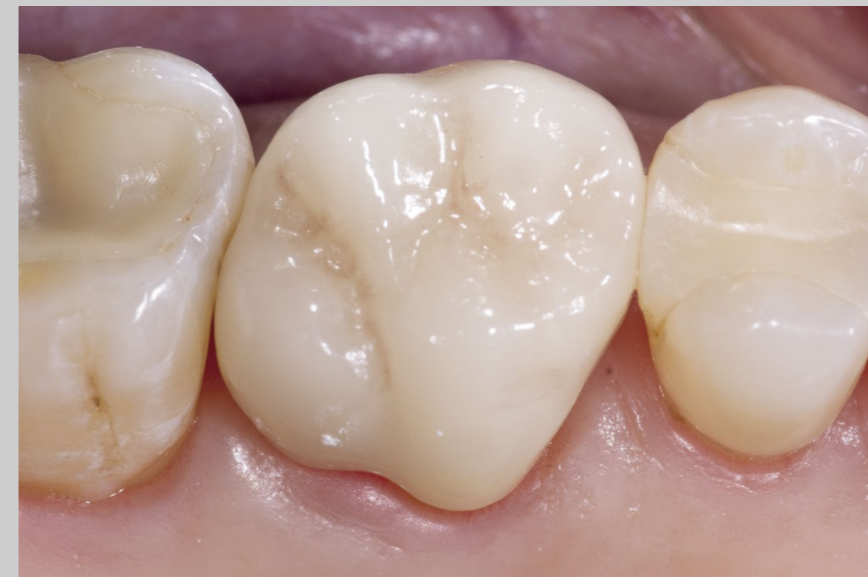
After:

Highly esthetic full-surface glass-ceramic crown.

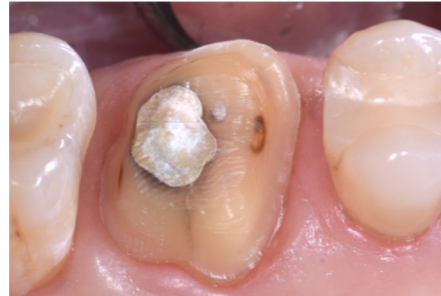
The previous failing restoration was removed, and both mesial and distal recurrent decay was found and excavated. No pulp was exposed upon completed excavation. A composite core buildup was completed using a glass ionomer liner (3M Vitrebond) and composite resin (Empress Opaque, Ivoclar Vivadent).

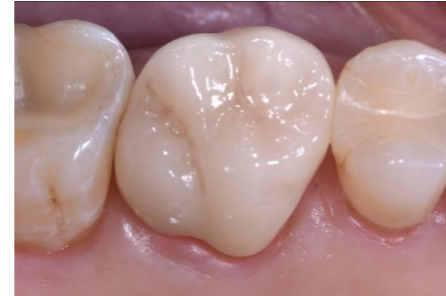
After crystallizing and stream cleaning the restoration, the e.max CAD was prepared for bonding and bonded with resin cement.

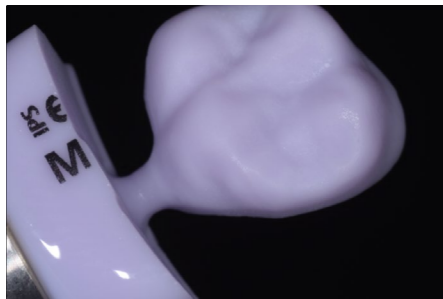
The local parameter marginal thickness was adjusted to 100 µm. The design phase was then completed with very little modification to the fissure height and contours. The design was evaluated for proper occlusion, contacts and contours.

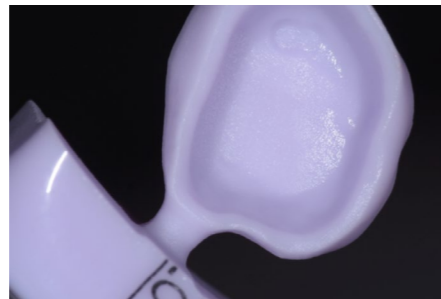
Since the touch process had been completed in advance, the grinding began right away after the restoration was sent to the CEREC Primemill. The e.max restoration was grinded in 3:54 without any marginal chipping. The fit was checked, and no further adjustments were needed.

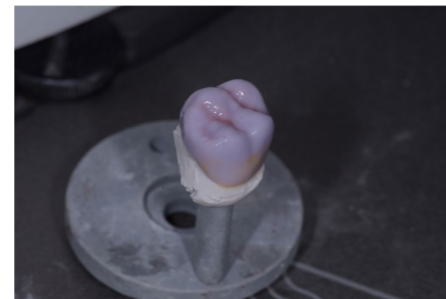
The restoration was then glazed and stained using Ivoclar Vivadent IPS e.max CAD Crystall Shades, Stains and Glaze Paste.

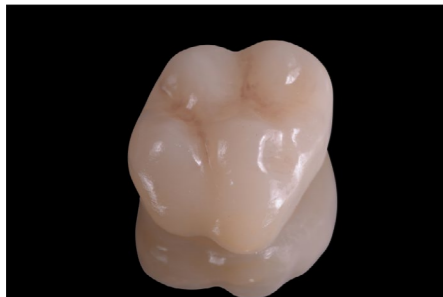
It was then crystallized in a furnace.

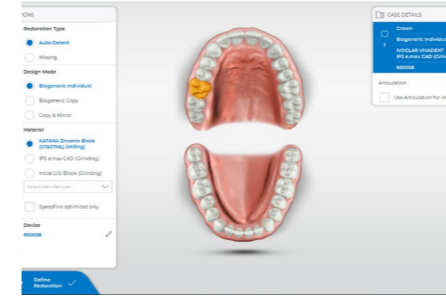
The patient information and the Administration Phase was completed, designating IPS e.max CAD for the restoration.

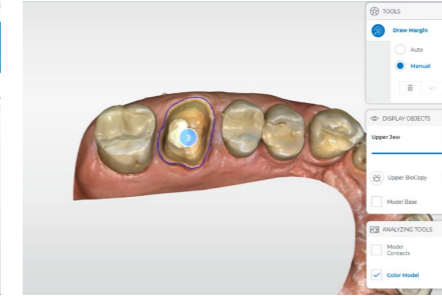
Automargination was completed by the software and no modifications were needed.

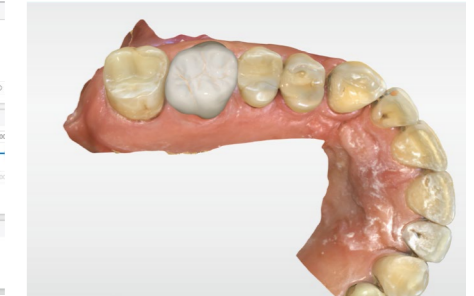
Design proposal.

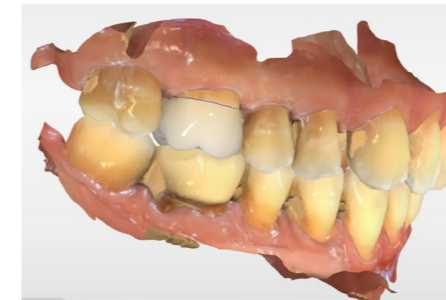
The design was evaluated for proper positioning, contours, occlusion, and contacts.

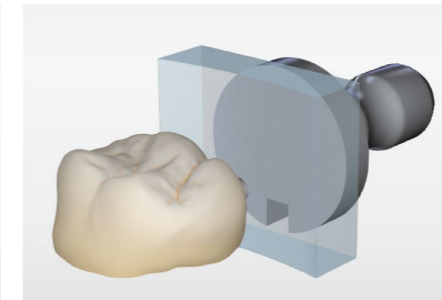
In the Manufacture Phase the sprue was automatically proposed on the lingual surface.

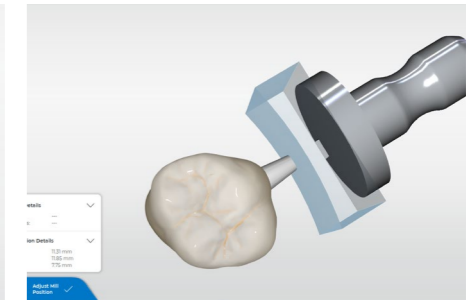
The restoration was then sent to the CEREC Primemill.
