Ankylos implant placement and IPS e.max CAD single crown – First upper premolar in 90 minutes

Case Description

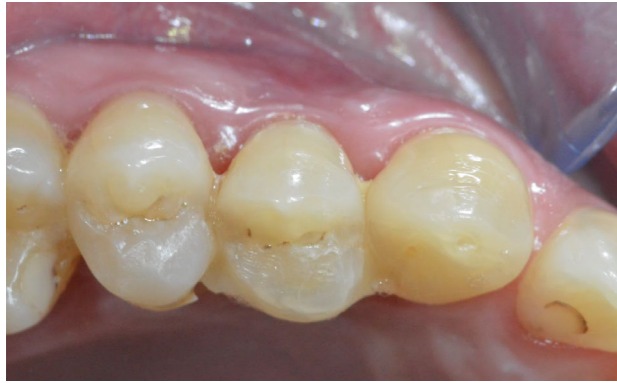
Horizontal root fracture and a periapical infection caused patient pain and some loosening of tooth 24.

A 56-year-old female patient came to my practice with pain and some loosening of tooth 24. After an initial examination, a CBCT scan was performed with Orthophos SL, which determined that a horizontal root fracture and a periapical infection were the cause of the problems. Together with the patient, it was decided to extract the fractured tooth and immediately restore the gap with an implant. At the next appointment, the tooth was gently removed. An implant (Ankylos A11) and a gingiva former were placed in the cleaned bony extraction socket and filled with particulated bone (Symbios Xenograft granules). The premolar crown was subsequently trimmed and reused as a temporary solution, while retaining the soft tissue contour. After a three-month healing period, the patient's final prosthetic restoration was started. Three scans of the maxilla were taken with CEREC Primescan: one scan of the temporary restoration (natural crown), which served as a reference for the permanent crown to be fabricated; another to record the soft tissue contour; and a third scan with the IO FLO-S scan body. In addition, a mandibular scan and a bite registration were carried out. CEREC Software was used for the design of the restoration in which the Biocopy setting was utilized. The gingival mask functioned as a reference for the emergence profile. The lithium disilicate crown (e.max CAD A14 block, Ivoclar Vivadent) was produced using CEREC Primemill. After crystallization (CEREC SpeedFire) and characterization, the restoration was cemented onto an Ankylos TitaniumBase. The crown itself was screwed to the implant and the screw channel filled with composite. This appointment took only a total of 90 minutes. At the follow-up visit five days later, the patient was very satisfied, saying, "It is as if nothing happened at all."

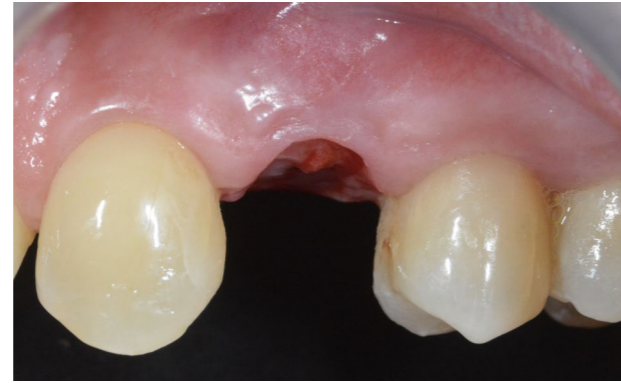
Extraction of fractured tooth

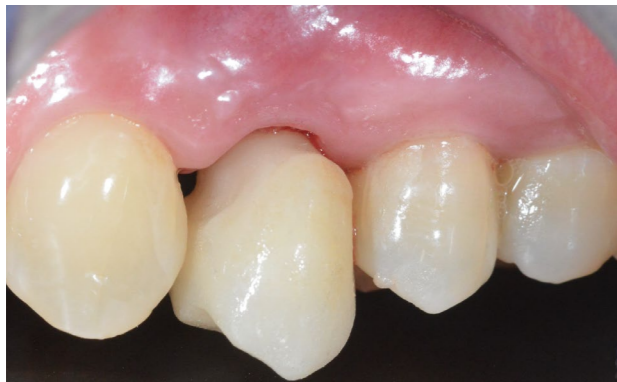
Three months later: final prosthetic restoration

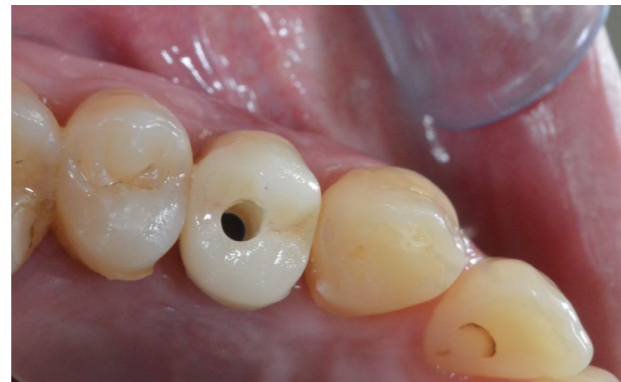
Result: preservation of esthetics and the natural soft tissue contour.

A possible alternative would have been a conservative treatment approach with root canal treatment and stabilization of tooth fragments. However, the patient rejected this due to the relatively high risk of failure as well as a previous negative experience. Restoration with a bridge after extraction of the affected tooth was also ruled out. The advantage of the selected implant treatment, especially using the natural tooth crown as a temporary restoration, was the preservation of esthetics and the natural soft tissue contour.

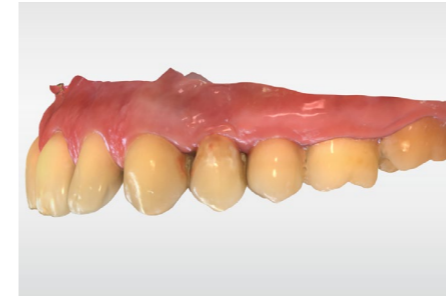
Scan of the temporary restoration (natural crown), which served as a reference for the permanent crown to be fabricated.

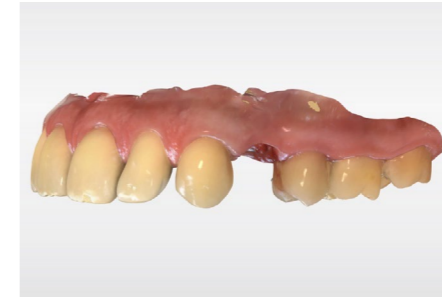
Scan after tooth was extracted to record the soft tissue contour.

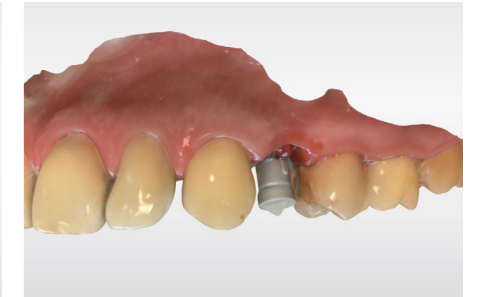
Scan with ScanPost and Scanbody.

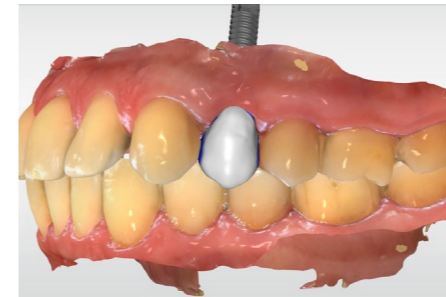
Restoration design.

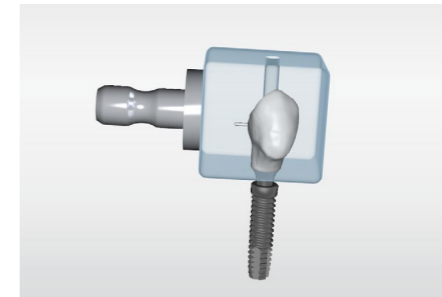
CEREC Primemill fast grinding mode was selected.

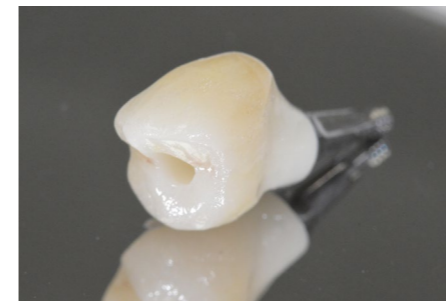
After crystallization and characterization, the restoration was cemented onto an Ankylos TitaniumBase.
