# A CEREC MTL Zirconia crown – Second upper premolar in 90 minutes

## Case Description

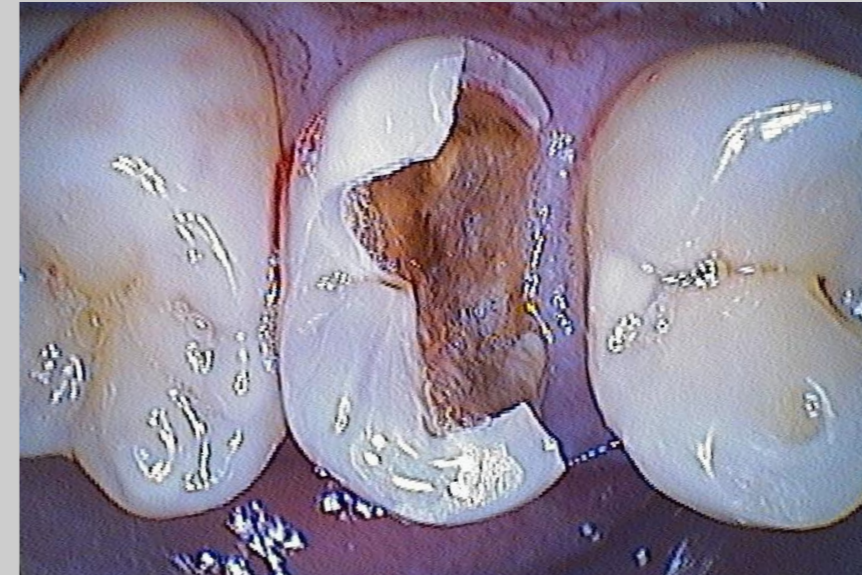
### Before:

A large carious mesial lesion on tooth 15. The tooth showed asymptomatic apical periodontitis and a significant loss of tooth structure.

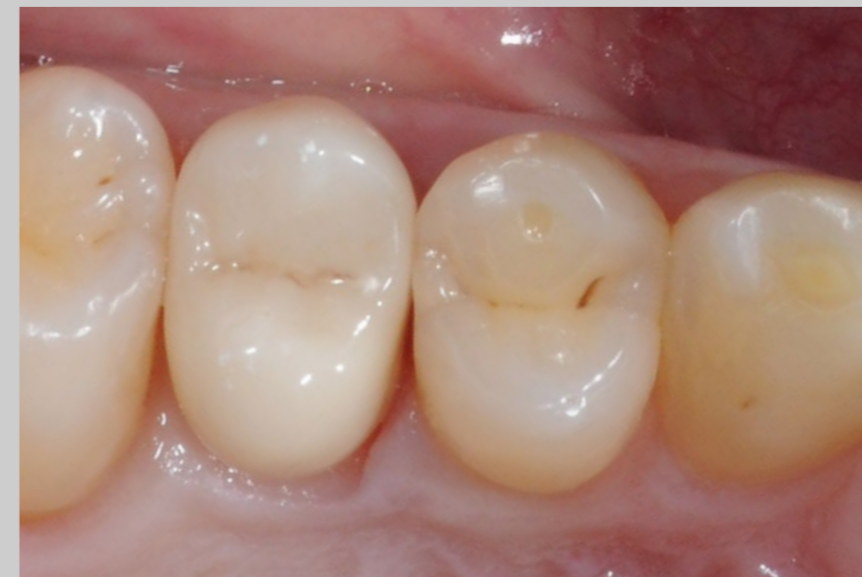
### After:

Chairside-fabricated restoration designed using the Biogeneric individual function. CEREC MTL Zirconia was the material selected because it promises both high strength and exceptionally good esthetics.

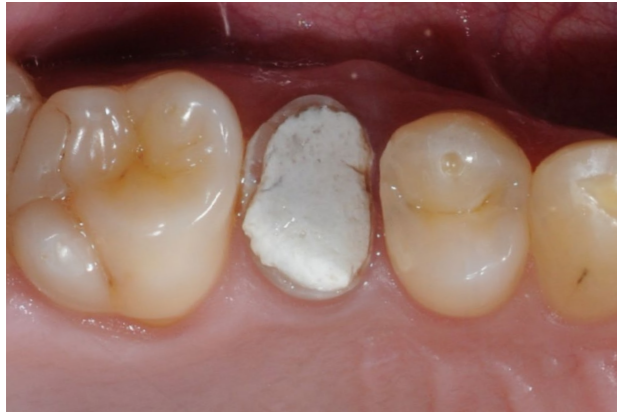
Initial situation after endodontic treatment: the mesial wall was temporarily built up here with composite for rubber dam placement.

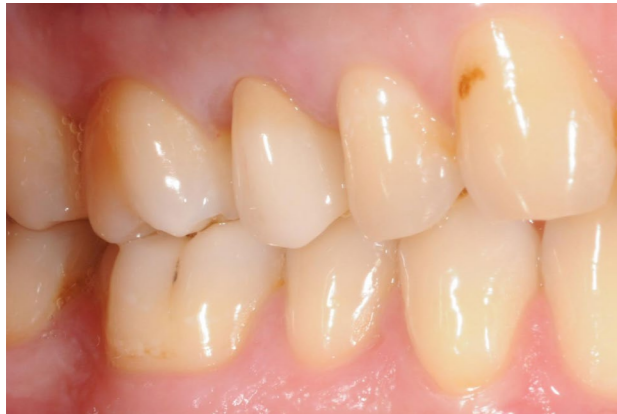
Final crown - buccal.

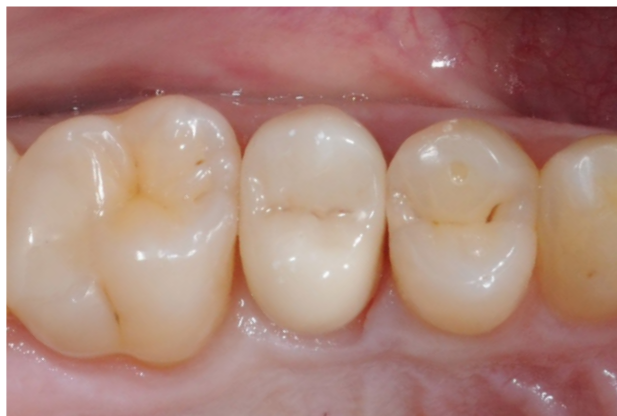
Final crown - occlusal.

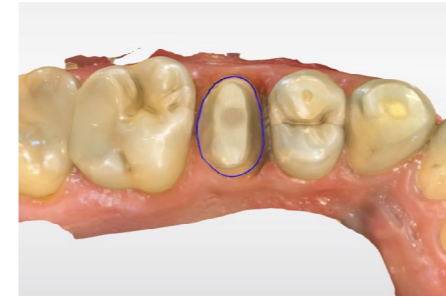
Crown margination.

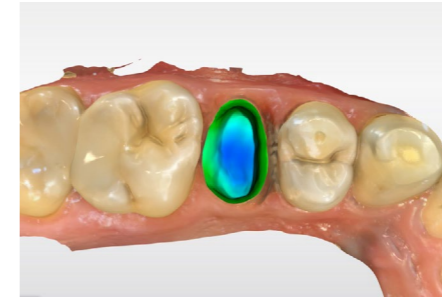
Image of crown preparation.

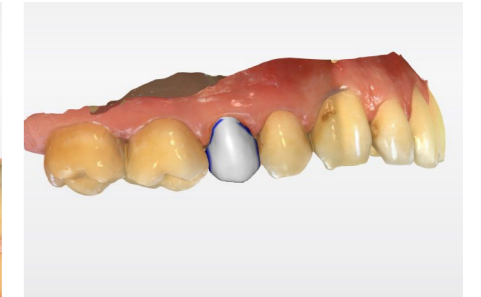
Design check - buccal.

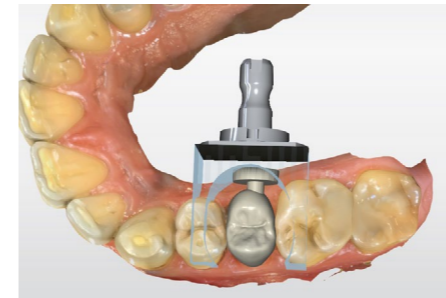
Manufacture preview of final crown.

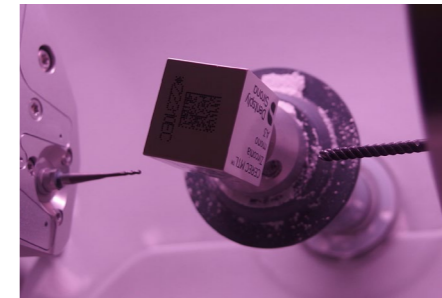
Crown milling with CEREC MTL Zirconia in CEREC Primemill.

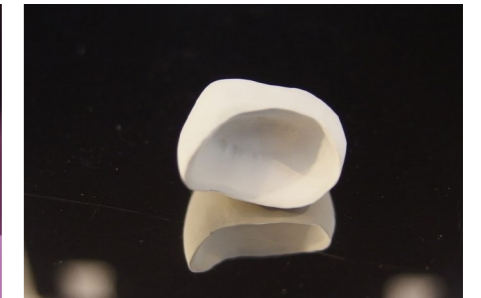
The crown right before sintering.

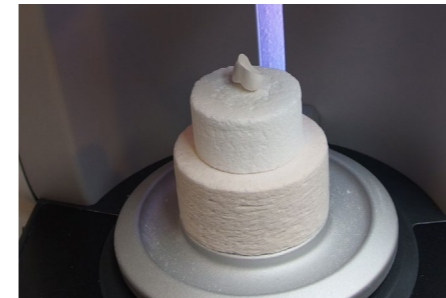
The crown is placed in CEREC SpeedFire.

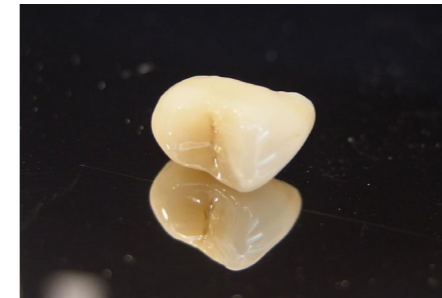
Final crown.
