Introduction to the case

A 35 year-old male came to our department after fracturing his upper right central incisor from a traffic accident. After a one-month follow-up period at our endodontics department, the tooth remained vital without any symptoms. As the patient preferred a minimally invasive procedure, direct composite restoration was selected for esthetic rehabilitation.

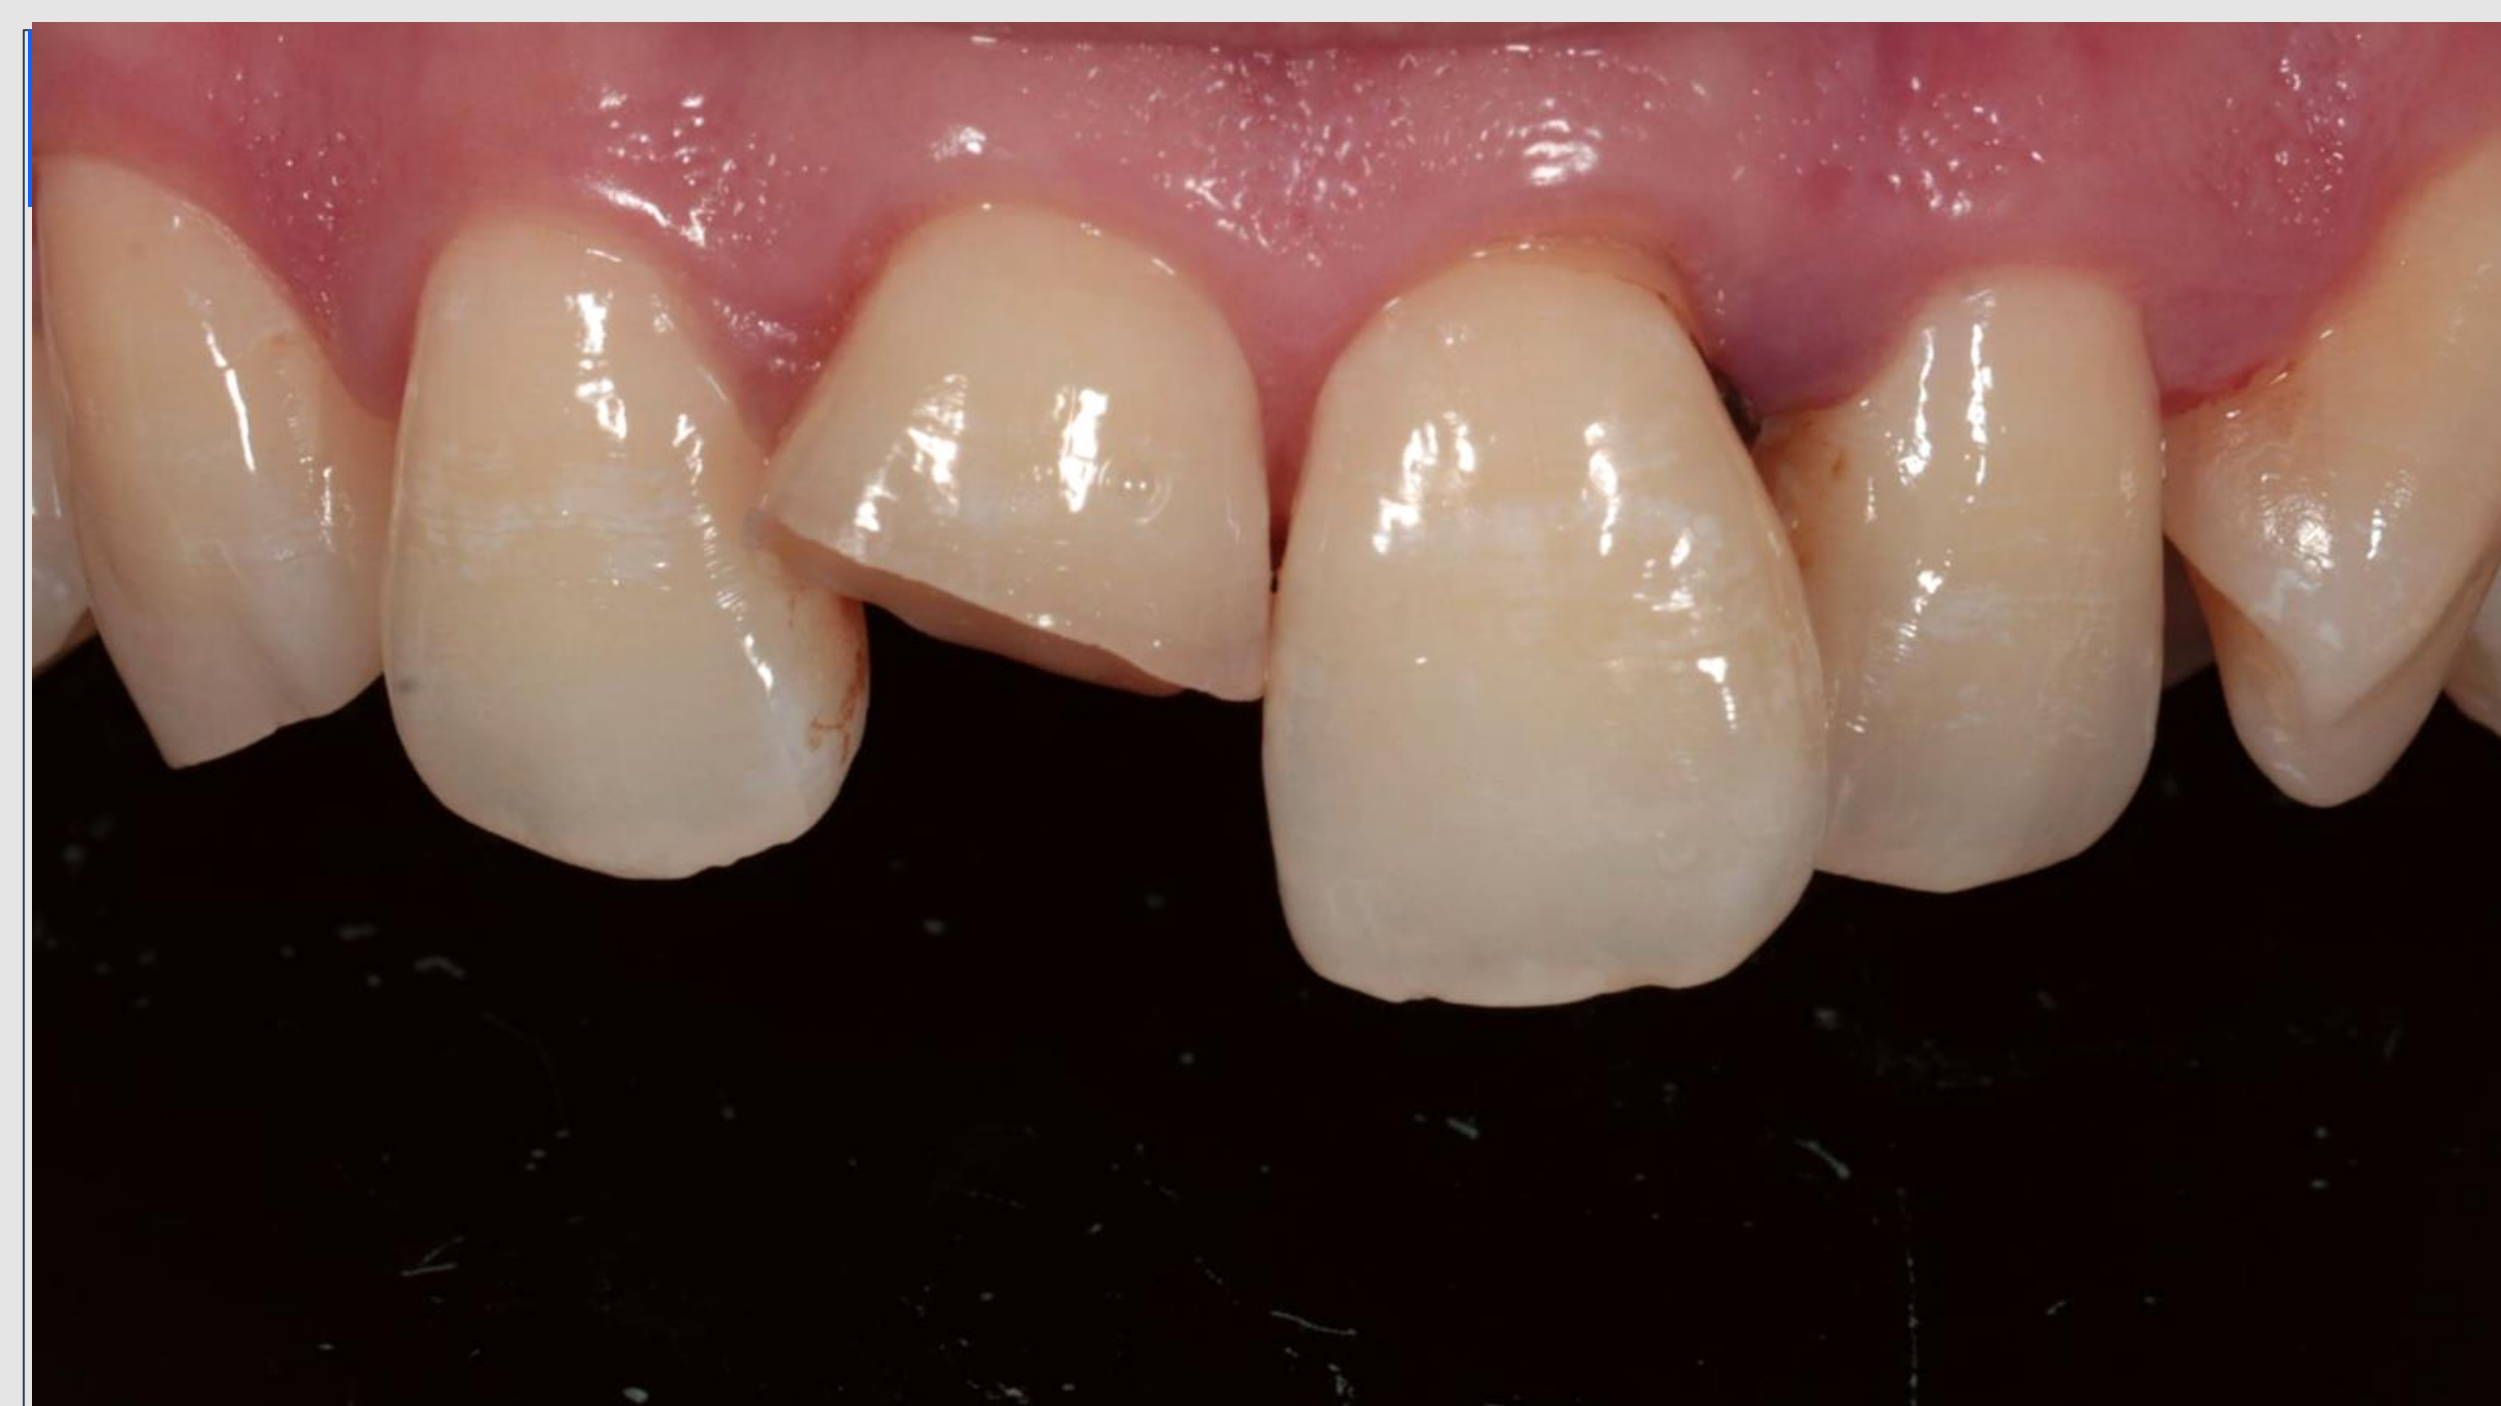
Pre-operative view of fractured tooth 11 with slight malalignment

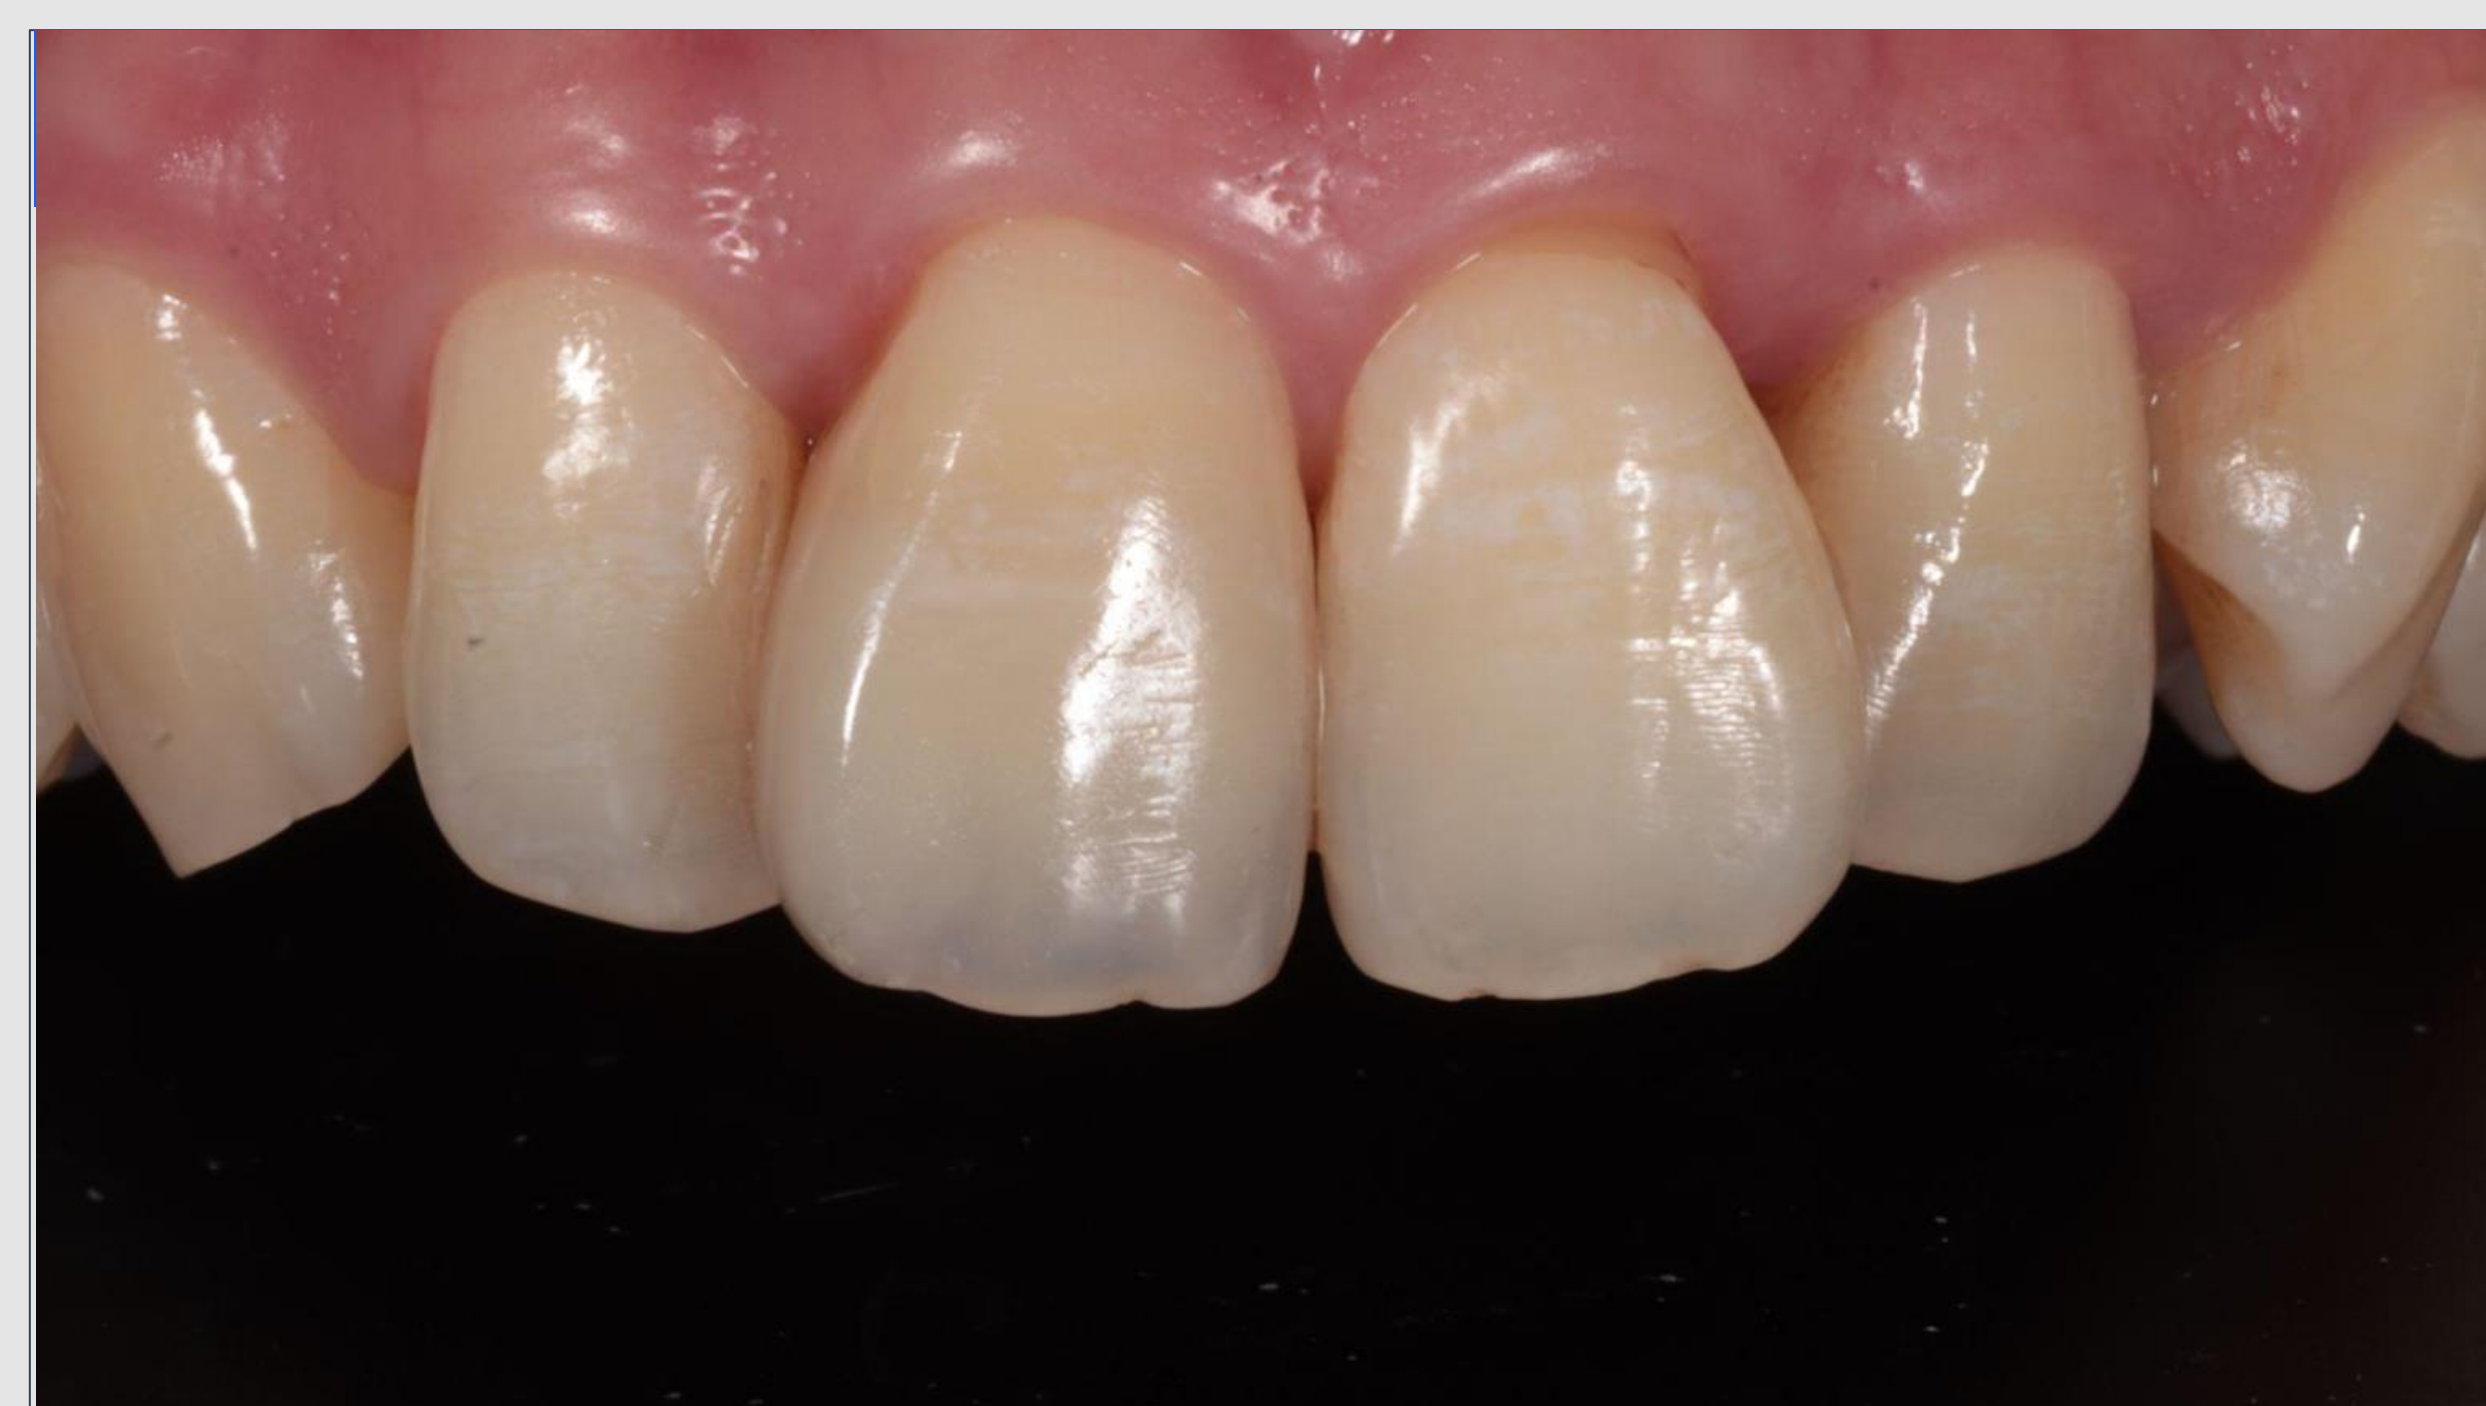
Post-operative view at 1-week follow-up

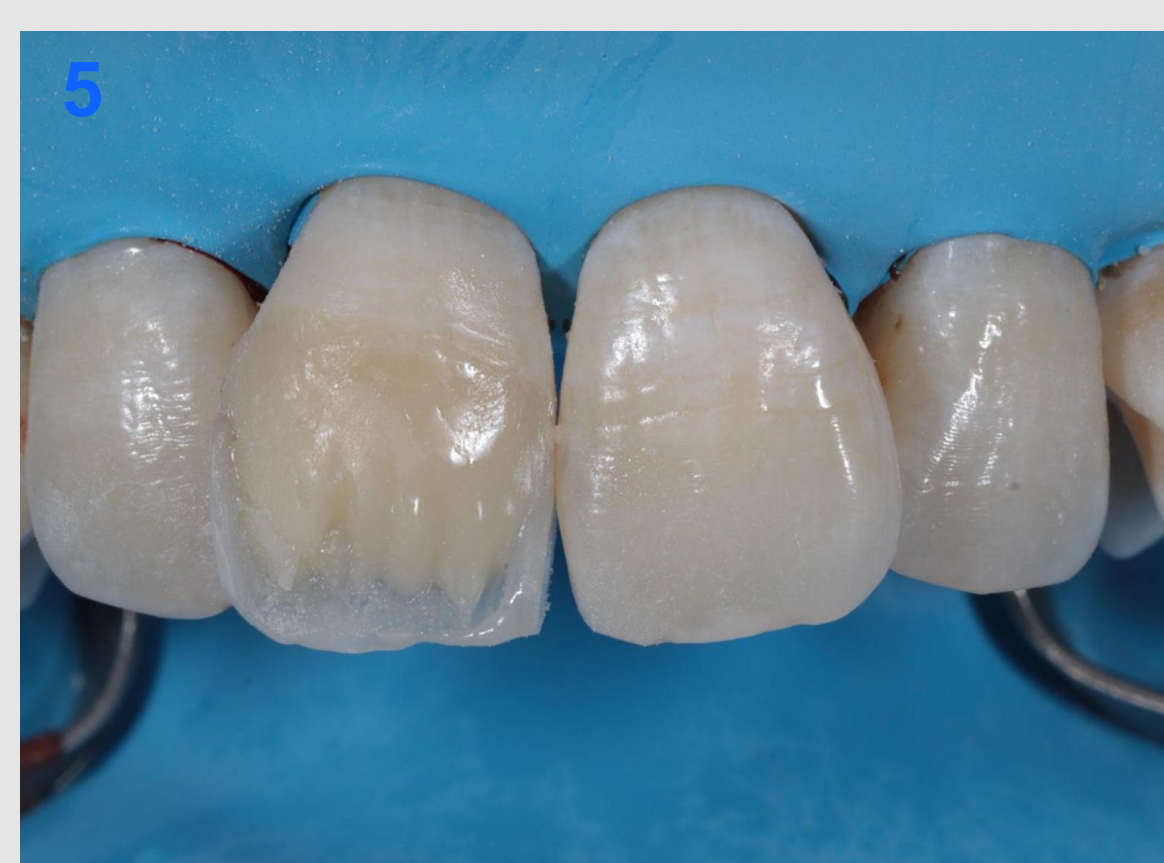
Layering

Upon examination, the dentin layer of tooth 21 is consisted of two stronger mamelons on the side with two smaller ones in the middle. Resin sculpted into the shape of mamelons was utilized to resemble the dentin body. A translucent effect is inserted into the mamelon depression.

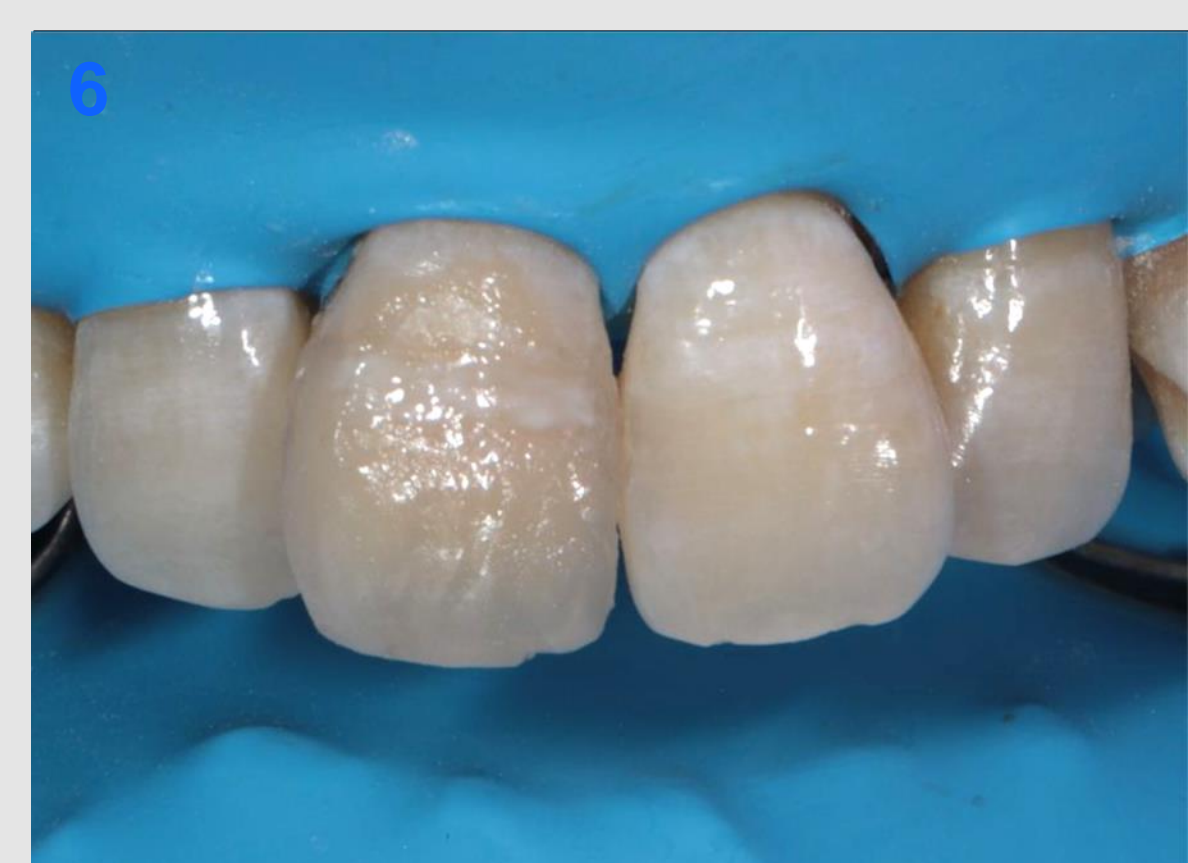
Tooth Characteristic Refinement

As white spots are evident over the cervical portion of tooth 21, the thicker band followed by the thinner striae were mimicked on the restoration. Finally, a final layer of enamel resin was placed to complete the build-up.

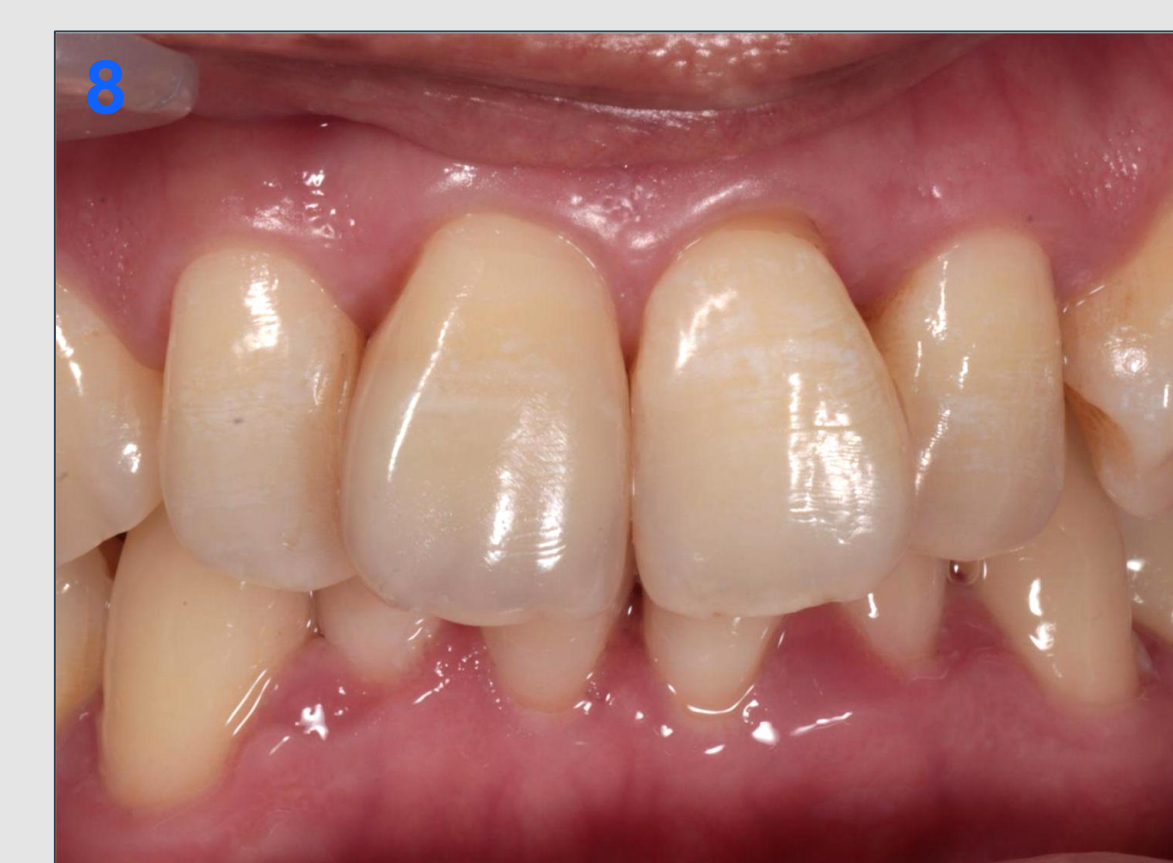
Rehydration

A 1-week postoperative view demonstrates a favorable integration of form and color. The tooth remained vital at the follow-up appointment.
