Global Clinical Case Contest 2022-2023

Ahmed Kamal **Tutor:** Prof. Nermeen Hamza **University:** October University for Modern Sciences and Arts (MSA) **Country:** Egypt

Introduction to the case

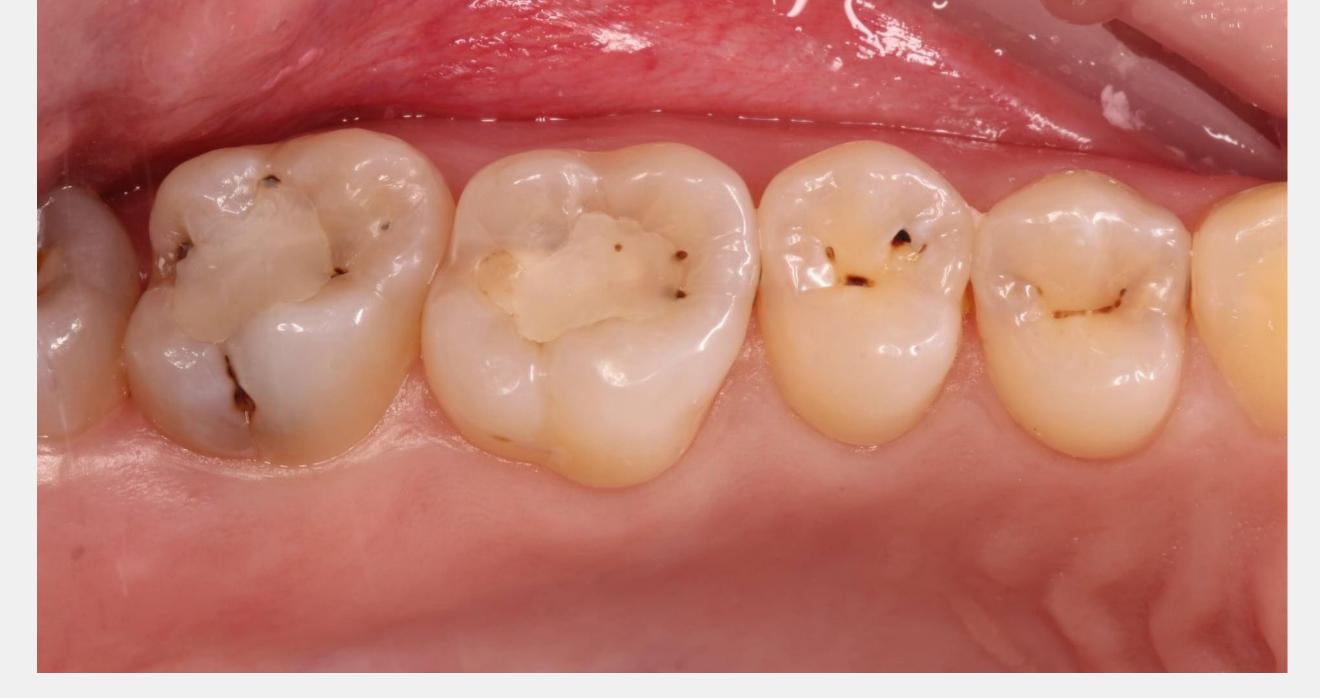
Before

A 35 years old male patient came to our restorative clinic complaining of pain in teeth: 1.4, 1.5, 1.6, 1.7 which had previously been treated 6 years ago. Examination reavealed defective composite restorations with reccurrent caries. After X-ray examination and comprehensive analysis it was decided to re-treat these teeth.

Initial view, before the treatment.

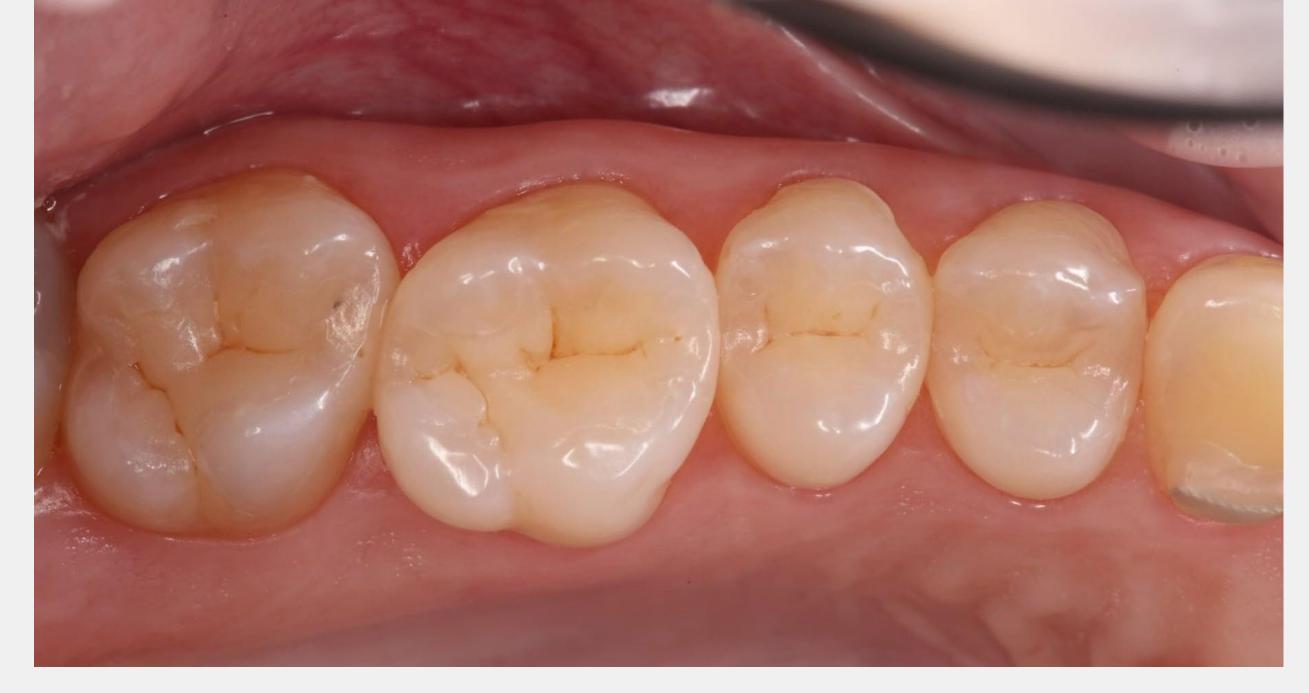
After rehydration.

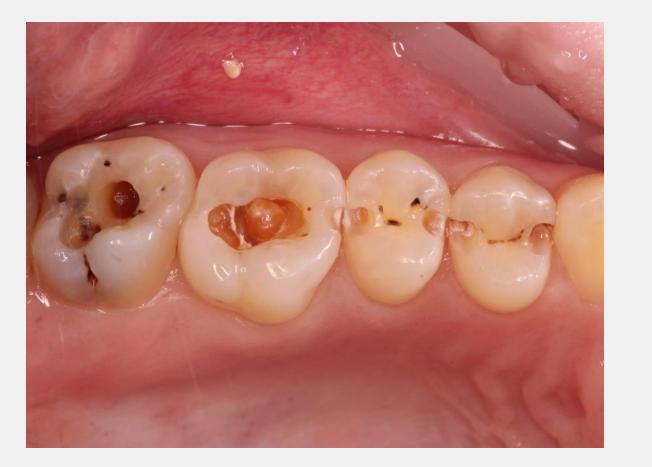
Step 1 Removal of defective restorations

Previous composite restorations have been removed.

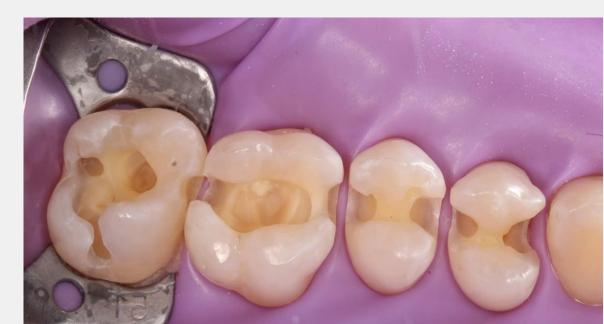
Step 2 Removal of the caries

All caries was removed by selective carious excavation to firm and hard dentine.

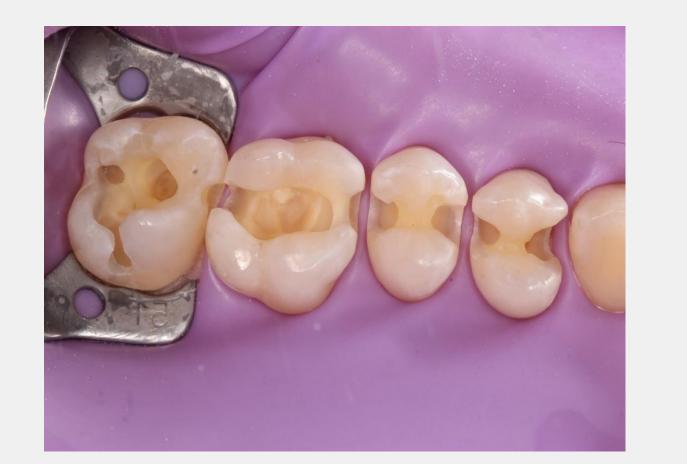
Step 3 Etching and Bonding

Isolation of the operative area using rubber dam. 37% phosphoric acid was applied to the enamel margins for 30 seconds. Adhesive protocol was made with **Prime&Bond Universal which was applied** using microbrush. **Step 4 Matricing**

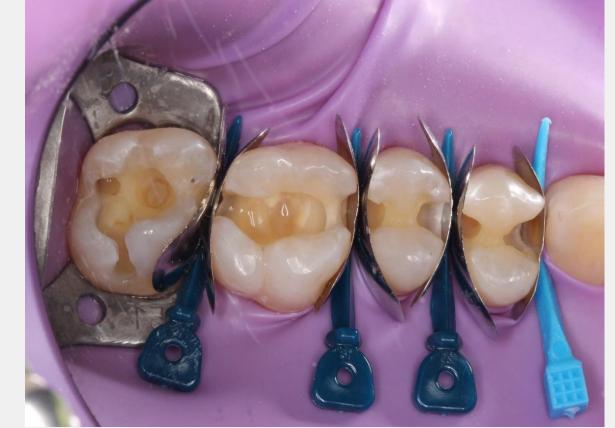
Application of the matrix system **Palodent V3**.

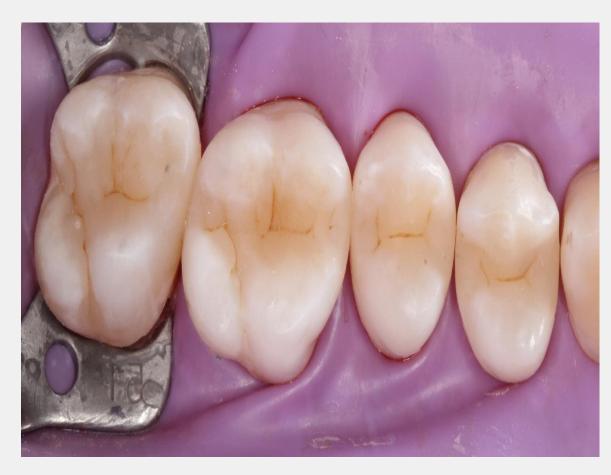
Step 5 Occlusal morphology

Occlusal morphology reconstruction by oblique incremental packing technique. By using **Neo Spectra ST** with **SphereTEC**.

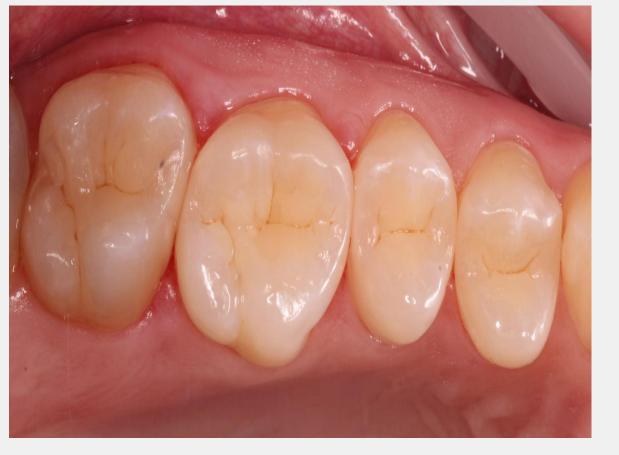
Step 6 Removal of oxygen-inhibited layer

The oxygen-inhibited layer was removed with **Enhance polishing cup**.

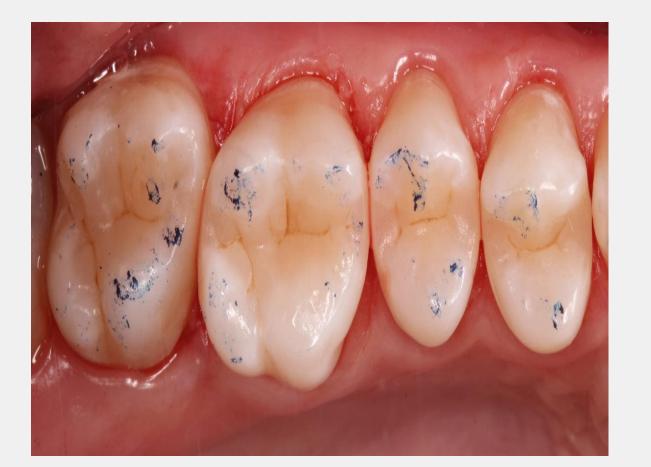
Step 7 Checking of occlusion

Occlusal finishing and then we monitored the premature contacts using articulating paper.

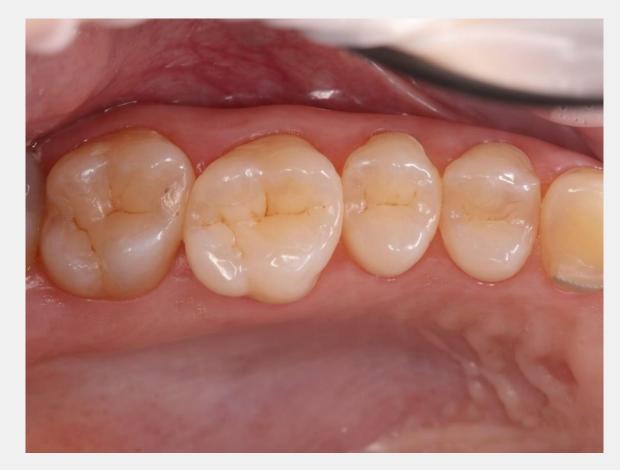
Step 8 Finishing and Polishing

Finishing and polishing was the final step using **Enhance** kit. Photo after the rehydration.
